# Access Compliance Report

## Public Rights-of-Way

### (Curb Ramps)

Intersection ID: 21061	Main Street: SARDIS_RD	Cross Street: SMITHFIELD_DR	Location: SW
ADA ID: D2CB0C13829A	Ramp Type: PerpDiag	Initial Pass/Fail: Fail	Overall Compliance: No
Severity Score: 25			
Codes/Mitigation Info/Possible Solution		Field Measurements/Component Compliance

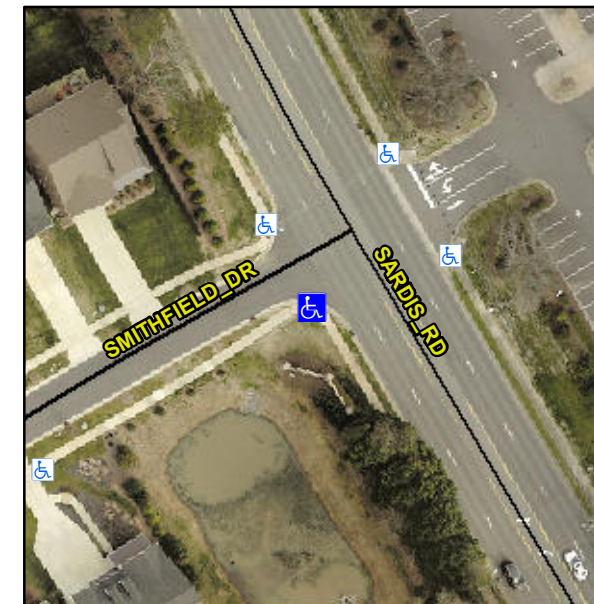
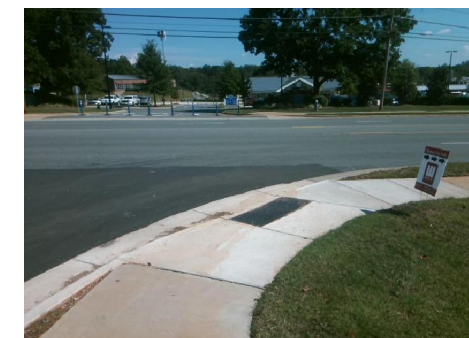
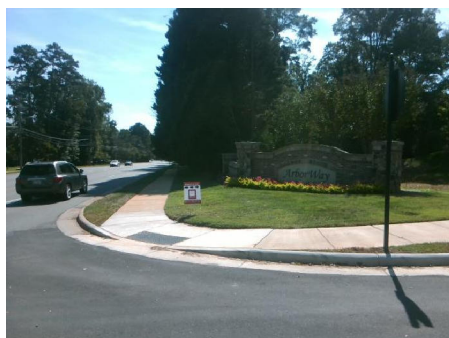
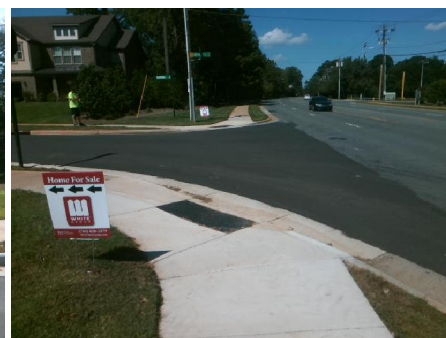
**Not Found, R304.2.2, R304.5.3**

Compliance	Description	Data	Compliance	Description	Data
N/A	Ramp Length (in)	60.0	No	Ramp Slope (%)	8.7
Yes	Ramp Width (in)	60.0	No	Ramp XSlope (%)	6.5
N/A	Flare Type LT	N/A	N/A	Flare Type RT	N/A
N/A	Flare Slope LT (%)	N/A	N/A	Flare Slope RT (%)	N/A
N/A	Flare Traversable LT?	N/A	N/A	Flare Traversable RT?	N/A
N/A	Landing Length (in)	N/A	N/A	DWS Provided?	N/A
N/A	Landing Width (in)	N/A	N/A	DWS Contrast?	N/A
N/A	Landing Slope (%)	N/A	N/A	DWS Length (in)	N/A
N/A	Landing X Slope (%)	N/A	N/A	DWS Full Width?	N/A
N/A	Landing Curb? (Y/N)	N/A	N/A	DWS Offset (in)	N/A
N/A	Shared Landing?	N/A			
N/A	Gutter Ponding?	N/A	N/A	Gutter Slope (%)	N/A
N/A	Gutter Lip Ht (in)	N/A	N/A	Gutter X Slope (%)	N/A
N/A	Painted X Walk1?	No	N/A	Painted X Walk2?	No
	X Walk 1 Direction	To E		X Walk 2 Direction	To N
N/A	X Walk 1 Width (in)	N/A	N/A	X Walk 2 Width (in)	N/A
	X Walk 1 Slope (%)	0.8		X Walk 2 Slope (%)	5.9
	X Walk 1 X Slope (%)	5.4		X Walk 2 X Slope (%)	3.0

N/A	Ramp inside XWalk1?	N/A	N/A	Ramp inside XWalk2?	N/A
	Road Slope (%)	4.3	N/A	Clear Space?	N/A
	Road X Slope (%)	3.7	N/A	Clear Space to XWalk (in)	N/A
N/A	Any Obstructions?	N/A	N/A	Storm Grate/Utility Hazard?	N/A
	Obstruction Type			Storm Grate/Utility Type	
		N/A			N/A
		Yes		Surface Condition? (G/P)	Good

**Remove & Replace Curb Ramp With Two New Directional Ramps or Equivalent.**
