Access Compliance Report

Public Rights-of-Way

(Curb Ramps)

Intersection ID: 45182	Main Street: MAPLEHURST_DR	Cross Street: SOCIETY_ST	Location: NE
ADA ID: D2DB8E38F9F1	Ramp Type: Perp	Initial Pass/Fail: Fail	Overall Compliance: No
Severity Score: 8.75			
Codes/Mitigation Info/Possible Solution		Field Measurements/Component Compliance

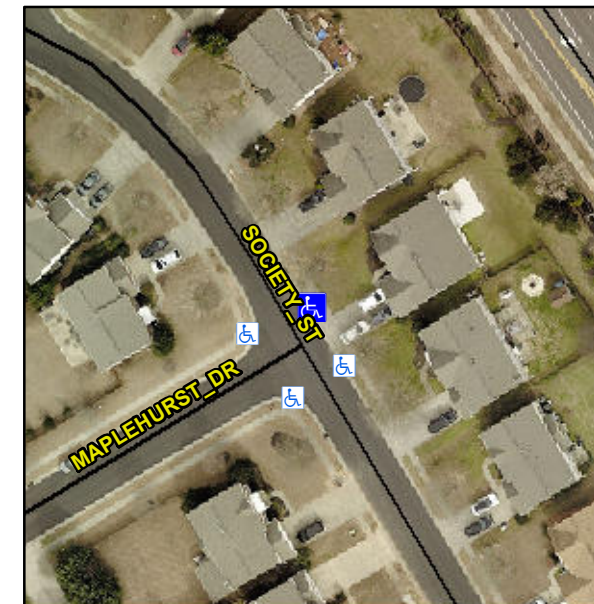
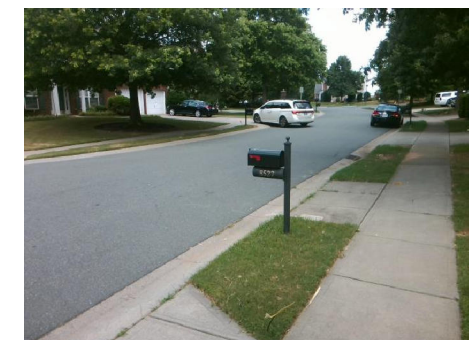
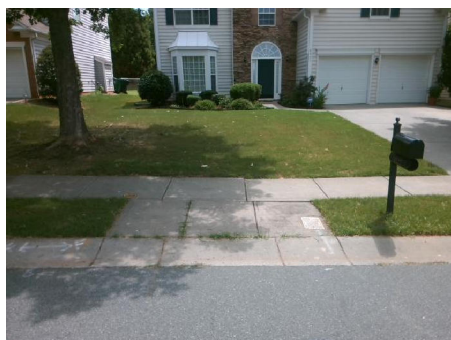
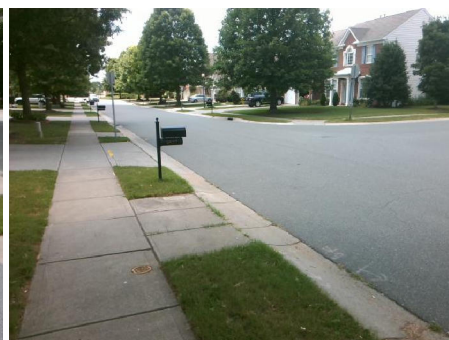
Not Found, R304.5.1

Compliance	Description	Data	Compliance	Description	Data
N/A	Ramp Length (in)	95.0	Yes	Ramp Slope (%)	5.9
No	Ramp Width (in)	37.5	Yes	Ramp XSlope (%)	1.8
N/A	Flare Type LT	N/A	N/A	Flare Type RT	N/A
N/A	Flare Slope LT (%)	N/A	N/A	Flare Slope RT (%)	N/A
N/A	Flare Traversable LT?	N/A	N/A	Flare Traversable RT?	N/A
N/A	Landing Length (in)	N/A	N/A	DWS Provided?	N/A
N/A	Landing Width (in)	N/A	N/A	DWS Contrast?	N/A
N/A	Landing Slope (%)	N/A	N/A	DWS Length (in)	N/A
N/A	Landing X Slope (%)	N/A	N/A	DWS Full Width?	N/A
N/A	Landing Curb? (Y/N)	N/A	N/A	DWS Offset (in)	N/A
N/A	Shared Landing?	N/A			
N/A	Gutter Ponding?	N/A	N/A	Gutter Slope (%)	N/A
N/A	Gutter Lip Ht (in)	N/A	N/A	Gutter X Slope (%)	N/A
N/A	Painted X Walk1?	No	N/A	Painted X Walk2?	N/A
	X Walk 1 Direction	To SW		X Walk 2 Direction	N/A
N/A	X Walk 1 Width (in)	N/A	N/A	X Walk 2 Width (in)	N/A
	X Walk 1 Slope (%)	3.1		X Walk 2 Slope (%)	N/A
	X Walk 1 X Slope (%)	1.7		X Walk 2 X Slope (%)	N/A

N/A	Ramp inside XWalk1?	N/A	N/A	Ramp inside XWalk2?	N/A
	Road Slope (%)	N/A	N/A	Clear Space?	N/A
	Road X Slope (%)	N/A	N/A	Clear Space to XWalk (in)	N/A
N/A	Any Obstructions?	N/A	N/A	Storm Grate/Utility Hazard?	N/A
	Obstruction Type			Storm Grate/Utility Type	
		N/A			N/A
			Yes	Surface Condition? (G/P)	Good

Remove & Replace Entire Ramp.
