Access Compliance Report

Public Rights-of-Way

(Curb Ramps)

Intersection ID: 11943	Main Street: PEGRAM_ST	Cross Street: KENNON_ST	Location: SW
ADA ID: D2E52E74865F	Ramp Type: Perp	Initial Pass/Fail: Fail	Overall Compliance: No
Codes/Mitigation Info/Possible Solution		Field Measurements/Component Compliance

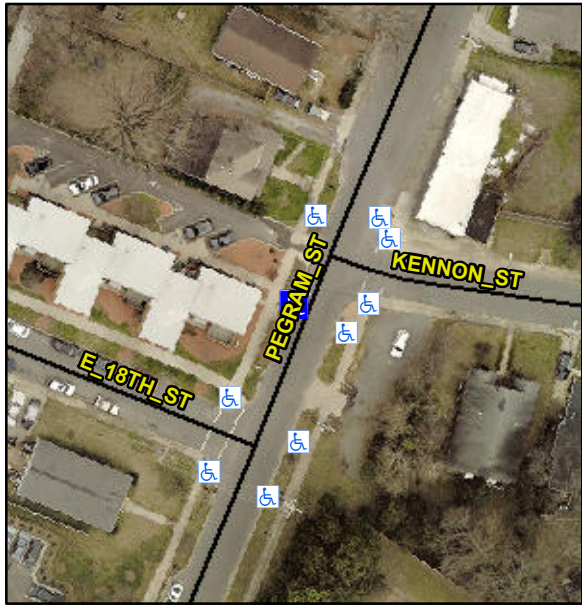
Compliance	Description	Data	Compliance	Description	Data
N/A	Ramp Length (in)	95.5	No	Ramp Slope (%)	8.7
Yes	Ramp Width (in)	48.0	Yes	Ramp XSlope (%)	2.4
N/A	Flare Type LT	N/A	N/A	Flare Type RT	N/A
N/A	Flare Slope LT (%)	N/A	N/A	Flare Slope RT (%)	N/A
N/A	Flare Traversable LT?	N/A	N/A	Flare Traversable RT?	N/A
N/A	Landing Length (in)	N/A	N/A	DWS Provided?	N/A
N/A	Landing Width (in)	N/A	N/A	DWS Contrast?	N/A
N/A	Landing Slope (%)	N/A	N/A	DWS Length (in)	N/A
N/A	Landing X Slope (%)	N/A	N/A	DWS Full Width?	N/A
N/A	Landing Curb? (Y/N)	N/A	N/A	DWS Offset (in)	N/A
N/A	Shared Landing?	N/A			
N/A	Gutter Ponding?	N/A	N/A	Gutter Slope (%)	N/A
N/A	Gutter Lip Ht (in)	N/A	N/A	Gutter X Slope (%)	N/A
N/A	Painted X Walk1?	No	N/A	Painted X Walk2?	N/A
	X Walk 1 Direction	To SE		X Walk 2 Direction	N/A
N/A	X Walk 1 Width (in)	N/A	N/A	X Walk 2 Width (in)	N/A
	X Walk 1 Slope (%)	4.1		X Walk 2 Slope (%)	N/A
	X Walk 1 X Slope (%)	3.1		X Walk 2 X Slope (%)	N/A

N/A	Ramp inside XWalk1?	N/A	N/A	Ramp inside XWalk2?	N/A
	Road Slope (%)	N/A	N/A	Clear Space?	N/A
	Road X Slope (%)	N/A	N/A	Clear Space to XWalk (in)	N/A
N/A	Any Obstructions?	N/A	N/A	Storm Grate/Utility Hazard?	N/A
	Obstruction Type			Storm Grate/Utility Type	
		N/A			N/A
			Yes	Surface Condition? (G/P)	Good

Possible Solutions:

Remove & Replace Entire Ramp.
