# Access Compliance Report

## Public Rights-of-Way

### (Curb Ramps)

| Intersection ID: 15174 | Main Street: DILWORTH_RD_WEST | Cross Street: IDEAL_WY | Location: NE |

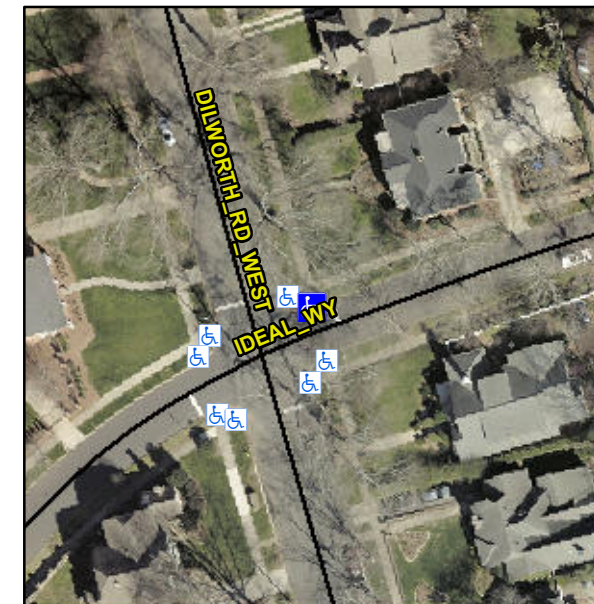
**Not Found, R304.2.2, R304.5.3**

| Compliance | Description | Data | Compliance | Description | Data |
|---|---|---|---|---|---|
| N/A | Ramp Length (in) | 79.0 | No | Ramp Slope (%) | 8.4 |
| Yes | Ramp Width (in) | 48.0 | No | Ramp XSlope (%) | 2.7 |

**Remove & Replace Entire Ramp.**

Total Cost: \$ 1850.00
