# Access Compliance Report

## Public Rights-of-Way

### (Curb Ramps)

Intersection ID: 52521	Main Street: LORNA_ST	Cross Street: MCCLINTOCK_RD	Location: S
ADA ID: D3092D7D8A0C	Ramp Type: Perp	Initial Pass/Fail: Pass	Overall Compliance: No
Severity Score: 0			
Codes/Mitigation Info/Possible Solution		Field Measurements/Component Compliance

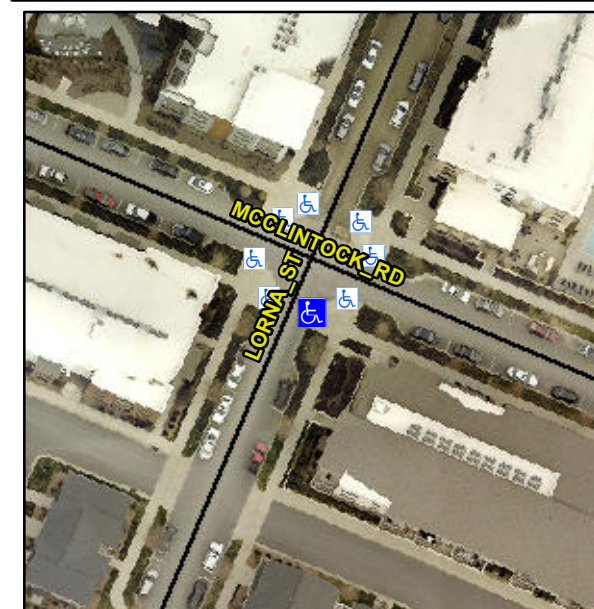
**Not Found, R305.2**

Compliance	Description	Data	Compliance	Description	Data
N/A	Ramp Length (in)	68.5	Yes	Ramp Slope (%)	5.2
Yes	Ramp Width (in)	71.5	Yes	Ramp XSlope (%)	0.5
N/A	Flare Type LT	Sloped	N/A	Flare Type RT	N/A
N/A	Flare Slope LT (%)	6.3	Yes	Flare Slope RT (%)	4.9
N/A	Flare Traversable LT?	Yes	N/A	Flare Traversable RT?	Yes
Yes	Landing Length (in)	71.5	Yes	DWS Provided?	Yes
Yes	Landing Width (in)	72.0	Yes	DWS Contrast?	Yes
Yes	Landing Slope (%)	0.8	Yes	DWS Length (in)	24.0
Yes	Landing X Slope (%)	0.7	Yes	DWS Full Width?	Yes
N/A	Landing Curb? (Y/N)	No	No	DWS Offset (in)	4.5
N/A	Shared Landing?	Yes			
Yes	Gutter Ponding?	No	Yes	Gutter Slope (%)	1.3
Yes	Gutter Lip Ht (in)	0.0	Yes	Gutter X Slope (%)	0.4
N/A	Painted X Walk1?	No	N/A	Painted X Walk2?	N/A
	X Walk 1 Direction	To NW		X Walk 2 Direction	N/A
N/A	X Walk 1 Width (in)	N/A	N/A	X Walk 2 Width (in)	N/A
	X Walk 1 Slope (%)	0.1		X Walk 2 Slope (%)	N/A
	X Walk 1 X Slope (%)	0.3		X Walk 2 X Slope (%)	N/A

N/A	Ramp inside XWalk1?	N/A	N/A	Ramp inside XWalk2?	N/A
	Road Slope (%)	N/A	N/A	Clear Space?	Yes
	Road X Slope (%)	N/A	N/A	Clear Space to XWalk (in)	N/A
Yes	Any Obstructions?	No	Yes	Storm Grate/Utility Hazard?	No
	Obstruction Type			Storm Grate/Utility Type	
		N/A			N/A
			Yes	Surface Condition? (G/P)	Good

Possible Solutions:

**Remove & Replace Entire Ramp.**
