Access Compliance Report

Public Rights-of-Way

(Curb Ramps)

Intersection ID: 8985	Main Street: ENNIS_AV	Cross Street: GRIMES_ST	Location: NE
ADA ID: D31607445937	Ramp Type: Directional2	Initial Pass/Fail: Fail	Overall Compliance: No
			Severity Score: 21.25

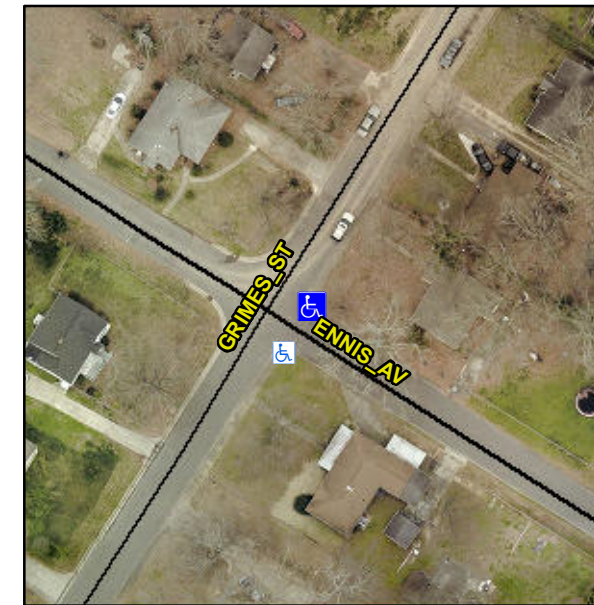
NO CURB

Compliance	Description	Data	Compliance	Description	Data
N/A	Ramp Length (in)	96.0	N/A	Grade Break?	N/A
No	Ramp Width (in)	38.0	N/A	Grade Break Slope (%)	0.0
Yes	Ramp Slope (%)	7.5	N/A	Grade Break XSlope (%)	0.0
No	Ramp XSlope (%)	6.8			
N/A	Flare Type LT	N/A	N/A	Flare Type RT	N/A
N/A	Flare Slope LT (%)	N/A	N/A	Flare Slope RT (%)	0.0
N/A	Flare Traversable LT?	N/A	N/A	Flare Traversable RT?	N/A
N/A	Landing Length (in)	0.0	N/A	DWS Provided?	N/A
N/A	Landing Width (in)	0.0	N/A	DWS Contrast?	N/A
N/A	Landing Slope (%)	0.0	N/A	DWS Length (in)	N/A
N/A	Landing X Slope (%)	0.0	N/A	DWS Full Width?	N/A
N/A	Landing Curb? (Y/N)	N/A	N/A	DWS Offset LT (in)	N/A
N/A	Shared Landing?	N/A	N/A	DWS Offset RT (in)	N/A
N/A	Gutter Ponding?	Yes	N/A	Gutter Slope (%)	N/A
N/A	Gutter Lip Ht (in)	0.0	N/A	Gutter X Slope (%)	N/A
N/A	Painted X Walk1?	No		Road Slope (%)	4.3
	X Walk 1 Direction	To SW		Road X Slope (%)	1.3
	X Walk 1 Width (in)	N/A		Clear Space?	N/A

X Walk 1 Slope (%)	4.3	N/A	Clear Space to XWalk (in)	N/A
	X Walk 1 X Slope (%)	1.3	N/A	Storm Grate/Utility Hazard?	N/A
N/A	Ramp inside XWalk1?	N/A		Storm Grate/Utility Type	
N/A	Any Obstructions?	N/A			N/A
	Obstruction Type		Yes	Surface Condition? (G/P)	Good
			N/A	Curb Slope (%)	N/A

Possible Solutions:

Remove & Replace Entire Ramp.
