## Access Compliance Report Public Rights-of-Way (Curb Ramps)

Intersection ID: 42684 Main Street: SHARON\_AV Cross Street: SHARON\_RD Location: SE

ADA ID: D31BB2B5E20B Ramp Type: PerpDiag Initial Pass/Fail: Fail Overall Compliance: No Severity Score: 33.75

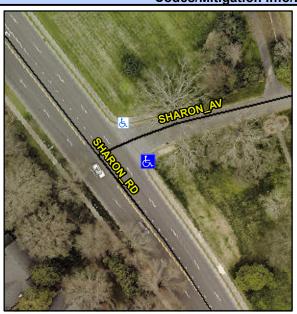
Not Found, R304.5.1, R304.5.3

| rield Measurements/Component Compilance | | | | | |
|---|---|---|---|---|---|
| No | Ramp Width (in) | 44.0 | No | Ramp XSlope (%) | 7.4 |

Remove & Replace Curb Ramp With Two New Directional Ramps or Equivalent.
