# Access Compliance Report

## Public Rights-of-Way

### (Curb Ramps)

Intersection ID: 12342	Main Street: E_8TH_ST	Cross Street: N_CALDWELL_ST	Location: N
ADA ID: D31E632C9B3F	Ramp Type: Perp	Initial Pass/Fail: Fail	Overall Compliance: No
		Severity Score: 35

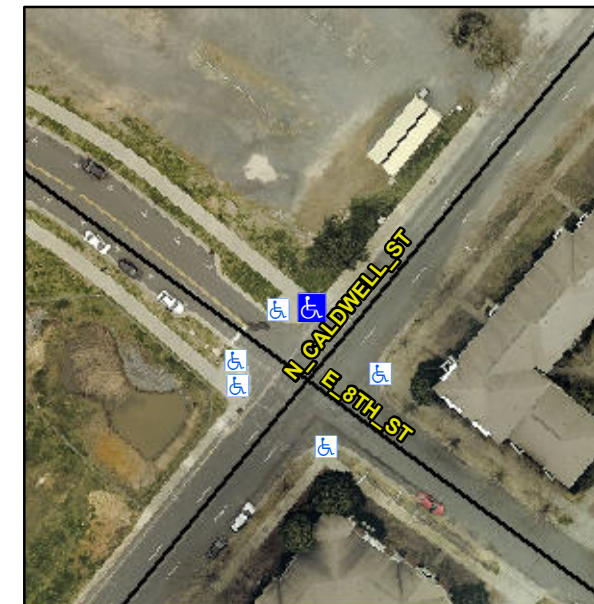
**Not Found, R304.5.1, R304.2.2**

Compliance	Description	Data	Compliance	Description	Data
N/A	Ramp Length (in)	62.0	No	Ramp Slope (%)	13.3
No	Ramp Width (in)	47.0	Yes	Ramp XSlope (%)	2.7
N/A	Flare Type LT	N/A	N/A	Flare Type RT	N/A
N/A	Flare Slope LT (%)	N/A	N/A	Flare Slope RT (%)	N/A
N/A	Flare Traversable LT?	N/A	N/A	Flare Traversable RT?	N/A
N/A	Landing Length (in)	N/A	N/A	DWS Provided?	N/A
N/A	Landing Width (in)	N/A	N/A	DWS Contrast?	N/A
N/A	Landing Slope (%)	N/A	N/A	DWS Length (in)	N/A
N/A	Landing X Slope (%)	N/A	N/A	DWS Full Width?	N/A
N/A	Landing Curb? (Y/N)	N/A	N/A	DWS Offset (in)	N/A
N/A	Shared Landing?	N/A			
N/A	Gutter Ponding?	N/A	N/A	Gutter Slope (%)	N/A
N/A	Gutter Lip Ht (in)	N/A	N/A	Gutter X Slope (%)	N/A
N/A	Painted X Walk1?	No	N/A	Painted X Walk2?	N/A
	X Walk 1 Direction	To SE		X Walk 2 Direction	N/A
N/A	X Walk 1 Width (in)	N/A	N/A	X Walk 2 Width (in)	N/A
	X Walk 1 Slope (%)	0.6		X Walk 2 Slope (%)	N/A
	X Walk 1 X Slope (%)	4.1		X Walk 2 X Slope (%)	N/A

N/A	Ramp inside XWalk1?	N/A	N/A	Ramp inside XWalk2?	N/A
	Road Slope (%)	N/A	N/A	Clear Space?	N/A
	Road X Slope (%)	N/A	N/A	Clear Space to XWalk (in)	N/A
N/A	Any Obstructions?	N/A	N/A	Storm Grate/Utility Hazard?	N/A
	Obstruction Type			Storm Grate/Utility Type	
		N/A			N/A
			Yes	Surface Condition? (G/P)	Good

**Remove & Replace Entire Ramp.**
