## **Access Compliance Report Public Rights-of-Way** (Curb Ramps)

Intersection ID: 24379 Main Street: BIRNEN DR **Cross Street: KINGS CANYON DR** Location: NW ADA ID: D3212EA2D910 Ramp Type: PerpDiag Initial Pass/Fail: Fail **Overall Compliance: No Severity Score:** 8.75

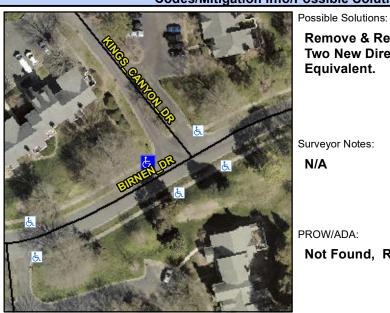
Not Found, R304.5.1

| Fleid Measurements/Component Compliance | | | | | | |
|---|---|---|---|---|---|--|
| No | Ramp Width (in) | 46.0 | Yes | Ramp XSlope (%) | 1.4 | |

Street 1 Name Stop Condition-Street 2 Street 2 Name Stop Condition-Street 1 Remove & Replace Curl **Two New Directional Ra** Equivalent.

Total Cost: 3200.00
