Access Compliance Report Public Rights-of-Way (Curb Ramps)

Intersection ID: 17759 Main Street: PARK_RD Cross Street: REECE_RD Location: SE

ADA ID: D329FFE23D49 Ramp Type: PerpDiag Initial Pass/Fail: Fail Overall Compliance: No Severity Score: 72.5

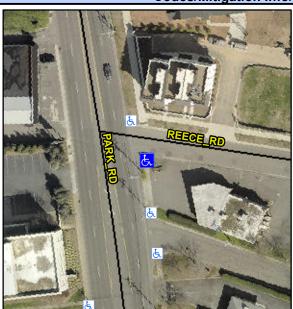
Not Found, R304.5.1, R304.2.2, R304.5.3

Field Measurements/Component Compliance					
Compliance Description		Data	Compliance Description		Data
N/A	A Ramp Length (in)	68.0	No	Ramp Slope (%)	11.9
No	Ramp Width (in)	26.0	No	Ramp XSlope (%)	8.2
N/A	A Flare Type LT	N/A	N/A	Flare Type RT	N/A
N/	A Flare Slope LT (%)	N/A	N/A	Flare Slope RT (%)	N/A
N/A	A Flare Traversable LT?	N/A	N/A	Flare Traversable RT?	N/A
N/A	A Landing Length (in)	N/A	N/A	DWS Provided?	N/A
N/A	A Landing Width (in)	N/A	N/A	DWS Contrast?	N/A
N/A	A Landing Slope (%)	N/A	N/A	DWS Length (in)	N/A
N/	A Landing X Slope (%)	N/A	N/A	DWS Full Width?	N/A
N/	A Landing Curb? (Y/N)	N/A	N/A	DWS Offset (in)	N/A
N/	A Shared Landing?	N/A			
N/	A Gutter Ponding?	N/A	N/A	Gutter Slope (%)	N/A
N/A	A Gutter Lip Ht (in)	N/A	N/A	Gutter X Slope (%)	N/A
N/	A Painted X Walk1?	No	N/A	Painted X Walk2?	No
	X Walk 1 Direction	To N		X Walk 2 Direction	To W
N/	X Walk 1 Width (in)	N/A	N/A	X Walk 2 Width (in)	N/A
	X Walk 1 Slope (%)	0.8		X Walk 2 Slope (%)	11.5

X Walk 1 X Slope (%)	10.8		X Walk 2 X Slope (%)	2.5
N/A	A Ramp inside XWalk1?	N/A	N/A	Ramp inside XWalk2?	N/A
	Road Slope (%)	9.8	N/A	Clear Space?	N/A
	Road X Slope (%)	7.5	N/A	Clear Space to XWalk (in)	N/A
N/	A Any Obstructions?	N/A	N/A	Storm Grate/Utility Hazard?	N/A
	Obstruction Type			Storm Grate/Utility Type	
		N/A			N/A
			Yes	Surface Condition? (G/P)	Good

Remove & Replace Curb Ramp With Two New Directional Ramps or Equivalent.
