Access Compliance Report

Public Rights-of-Way

(Curb Ramps)

Intersection ID: N/A	Main Street: CANTERBURY CASTLE DR	Cross Street: SAGMORE HILL DR	Location: S
ADA ID: D336EDC0A7EF	Ramp Type: Perp	Initial Pass/Fail: Fail	Overall Compliance: No
Severity Score: 10			
Codes/Mitigation Info/Possible Solution		Field Measurements/Component Compliance

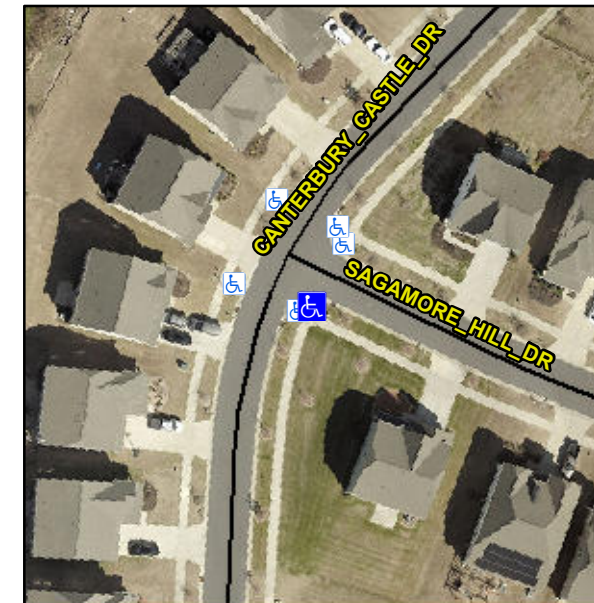
Compliance	Description	Data	Compliance	Description	Data
N/A	Ramp Length (in)	98.0	Yes	Ramp Slope (%)	6.7
No	Ramp Width (in)	45.0	No	Ramp XSlope (%)	4.2
N/A	Flare Type LT	N/A	N/A	Flare Type RT	N/A
N/A	Flare Slope LT (%)	N/A	N/A	Flare Slope RT (%)	N/A
N/A	Flare Traversable LT?	N/A	N/A	Flare Traversable RT?	N/A
N/A	Landing Length (in)	N/A	N/A	DWS Provided?	N/A
N/A	Landing Width (in)	N/A	N/A	DWS Contrast?	N/A
N/A	Landing Slope (%)	N/A	N/A	DWS Length (in)	N/A
N/A	Landing X Slope (%)	N/A	N/A	DWS Full Width?	N/A
N/A	Landing Curb? (Y/N)	N/A	N/A	DWS Offset (in)	N/A
N/A	Shared Landing?	N/A			
N/A	Gutter Ponding?	N/A	N/A	Gutter Slope (%)	N/A
N/A	Gutter Lip Ht (in)	N/A	N/A	Gutter X Slope (%)	N/A
N/A	Painted X Walk1?	No	N/A	Painted X Walk2?	N/A
	X Walk 1 Direction	To NE		X Walk 2 Direction	N/A
N/A	X Walk 1 Width (in)	N/A	N/A	X Walk 2 Width (in)	N/A
	X Walk 1 Slope (%)	0.8		X Walk 2 Slope (%)	N/A
	X Walk 1 X Slope (%)	3.0		X Walk 2 X Slope (%)	N/A

N/A	Ramp inside XWalk1?	N/A	N/A	Ramp inside XWalk2?	N/A
	Road Slope (%)	N/A	N/A	Clear Space?	N/A
	Road X Slope (%)	N/A	N/A	Clear Space to XWalk (in)	N/A
N/A	Any Obstructions?	N/A	N/A	Storm Grate/Utility Hazard?	N/A
	Obstruction Type			Storm Grate/Utility Type	
		N/A			N/A
			Yes	Surface Condition? (G/P)	Good

Possible Solutions:

Remove & Replace Entire Ramp.

PROW/ADA:

R304.5.1, R304.5.3
