## **Access Compliance Report Public Rights-of-Way** (Curb Ramps)

Intersection ID: 15786 Main Street: N\_SHARON\_AMITY\_RD Cross Street: AMITY PL Location: NW ADA ID: D33866769FA8 Ramp Type: Perp Initial Pass/Fail: Fail **Overall Compliance: No** Severity Score: 21.25

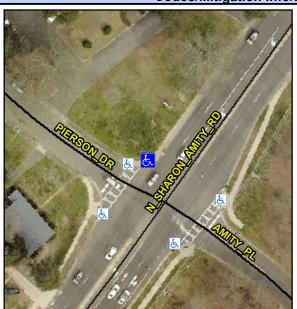
N/A Ramp Length (in) 60.0 No Ramp Slope (%)   No Ramp Width (in) 38.0 Yes Ramp XSlope (%)   N/A Flare Type LT N/A N/A Flare Type RT	8.7 0.5 N/A N/A N/A N/A
NoRamp Width (in)38.0YesRamp XSlope (%)N/AFlare Type LTN/AN/AFlare Type RT	0.5 N/A N/A N/A N/A
N/A Flare Type LT N/A N/A Flare Type RT	N/A N/A N/A N/A N/A
31	N/A N/A N/A N/A
N/A Flare Slope LT (%) N/A N/A Flare Slope RT (%)	N/A N/A N/A N/A
	N/A N/A N/A
N/A Flare Traversable LT? N/A N/A Flare Traversable RT?	N/A N/A
N/A Landing Length (in) N/A N/A DWS Provided?	N/A
N/A Landing Width (in) N/A N/A DWS Contrast?	
N/A Landing Slope (%) N/A N/A DWS Length (in)	
N/A Landing X Slope (%) N/A N/A DWS Full Width?	N/A
N/A Landing Curb? (Y/N) N/A N/A DWS Offset (in)	N/A
N/A Shared Landing? N/A	
N/A Gutter Ponding? N/A N/A Gutter Slope (%)	N/A
N/A Gutter Lip Ht (in) N/A N/A Gutter X Slope (%)	N/A
N/A Painted X Walk1? No N/A Painted X Walk2?	N/A
X Walk 1 Direction To SE X Walk 2 Direction	N/A

N/A X Walk 1 Width (in) N/A N/A X Walk 2 Width (in)	N/A
X Walk 1 Slope (%) 1.6 X Walk 2 Slope (%)	N/A
X Walk 1 X Slope (%) 1.5 X Walk 2 X Slope (%)	N/A
N/A Ramp inside XWalk1? N/A N/A Ramp inside XWalk2?	N/A
Road Slope (%) N/A Clear Space?	N/A
Road X Slope (%) N/A N/A Clear Space to XWalk (in)	N/A
N/A Any Obstructions? N/A N/A Storm Grate/Utility Hazard?	N/A
Obstruction Type Storm Grate/Utility Type	
N/A	N/A
Yes Surface Condition? (G/P) G	ood

N SHARON AMITY RD Street 1 Name Stop Condition-Street 2 None Street 2 Name N/A Stop Condition-Street 1 N/A Possible Solutions: Remove & Replace Entire Ramp. Surveyor Notes: N/A PROW/ADA: Not Found, R304.5.1, R304.2.2
