Access Compliance Report

Public Rights-of-Way

(Curb Ramps)

Intersection ID: 18752	Main Street: SENECA_PL	Cross Street: STANFIELD_DR	Location: W
ADA ID: D33A11F8ECF8	Ramp Type: BlendTrans1	Initial Pass/Fail: Fail	Overall Compliance: No
			Severity Score: 21.25

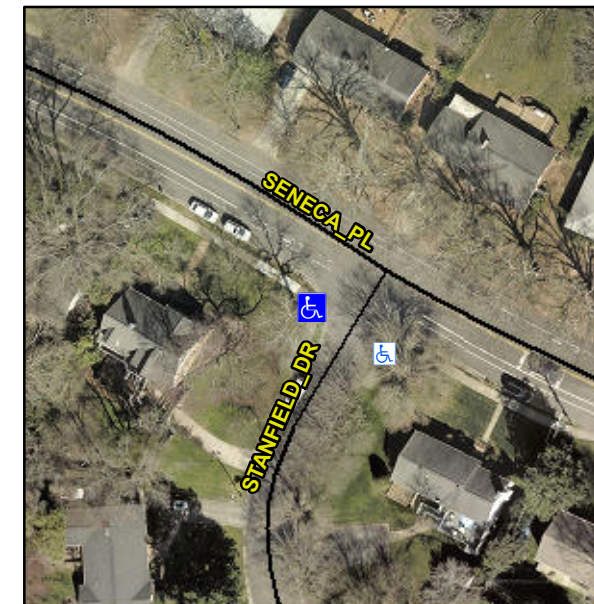
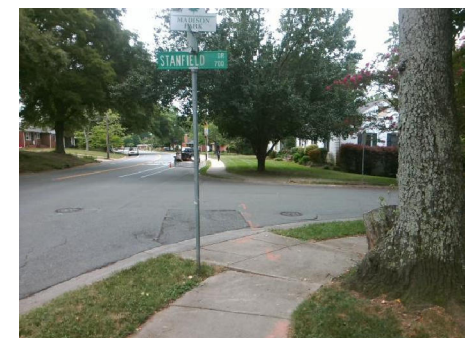
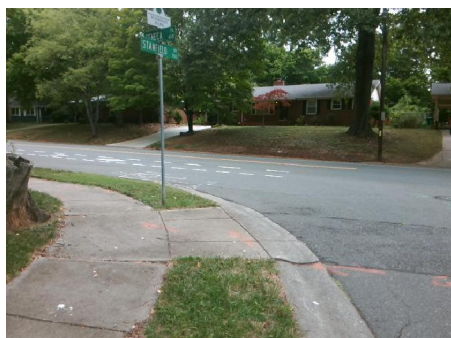
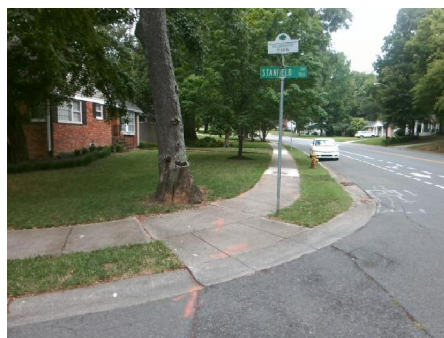
Not Found, R304.5.1, R304.5.3

Compliance	Description	Data	Compliance	Description	Data
N/A	Ramp Length (in)	48.0	Yes	BlendTrans Slope (%)	4.3
No	Ramp Width (in)	41.0	No	BlendTrans XSlope (%)	6.3
N/A	Flare Type LT	N/A	N/A	Flare Type RT	N/A
N/A	Flare Slope LT (%)	N/A	N/A	Flare Slope RT (%)	N/A
N/A	Flare Traversable LT?	N/A	N/A	Flare Traversable RT?	N/A
N/A	Landing Length (in)	N/A	N/A	DWS Provided?	N/A
N/A	Landing Width (in)	N/A	N/A	DWS Contrast?	N/A
N/A	Landing Slope (%)	N/A	N/A	DWS Length (in)	N/A
N/A	Landing X Slope (%)	N/A	N/A	DWS Full Width?	N/A
N/A	Landing Curb? (Y/N)	N/A	N/A	DWS Offset (in)	N/A
N/A	Shared Landing?	N/A			
N/A	Gutter Ponding?	N/A	N/A	Gutter Slope (%)	N/A
N/A	Gutter Lip Ht (in)	N/A	N/A	Gutter X Slope (%)	N/A
N/A	Painted X Walk1?	No	N/A	Painted X Walk2?	No
	X Walk 1 Direction	To SE		X Walk 2 Direction	To NE
	X Walk 1 Width (in)	N/A		X Walk 2 Width (in)	N/A
	X Walk 1 Slope (%)	3.0		X Walk 2 Slope (%)	5.2
	X Walk 1 X Slope (%)	3.5		X Walk 2 X Slope (%)	2.4

N/A	Ramp inside XWalk1?	N/A	N/A	Ramp inside XWalk2?	N/A
	Road Slope (%)	4.2		Clear Space?	N/A
	Road X Slope (%)	3.9	N/A	Clear Space to XWalk (in)	N/A
N/A	Any Obstructions?	N/A	N/A	Storm Grate/Utility Hazard?	N/A
	Obstruction Type			Storm Grate/Utility Type	
		N/A			N/A
			Yes	Surface Condition? (G/P)	Good
			No	Curb Slope (%)	8.7

Remove & Replace Curb Ramp With Two New Directional Ramps or Equivalent.
