Access Compliance Report

Public Rights-of-Way

(Curb Ramps)

| Intersection ID: 19528 | Main Street: SOUTH_BV | Cross Street: EMERYWOOD_DR | Location: NE |

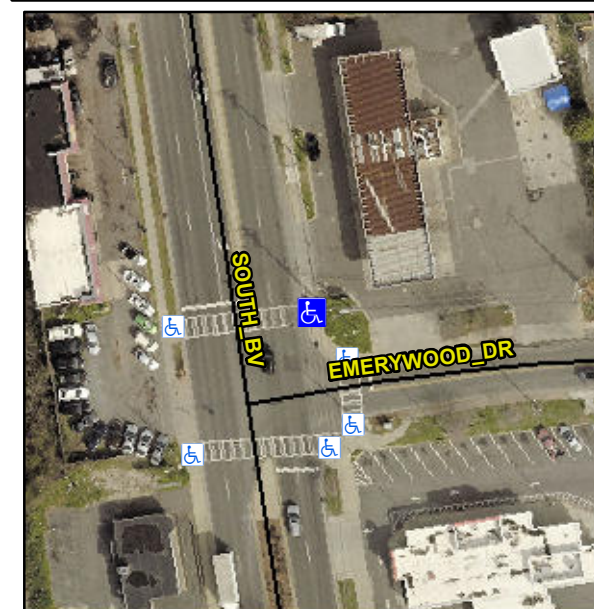
| ADA ID: D35C8439781C | Ramp Type: Perp | Initial Pass/Fail: Fail | Overall Compliance: No |
| | | Severity Score: 12.5 | |

Not Found, R304.2.2

| Compliance | Description | Data | Compliance | Description | Data |
|---|---|---|---|---|---|
| N/A | Ramp Length (in) | 69.0 | No | Ramp Slope (%) | 8.8 |

Possible Solutions:

Remove & Replace Entire Ramp.

Total Cost: \$ 1850.00
