Access Compliance Report

Public Rights-of-Way

(Curb Ramps)

Intersection ID: 50705	Main Street: HARMONIOUS_ST	Cross Street: GENERATIONS_ST	Location: NW
ADA ID: D36E06E78448	Ramp Type: PerpDiag	Initial Pass/Fail: Fail	Overall Compliance: No
		Severity Score: 37.5

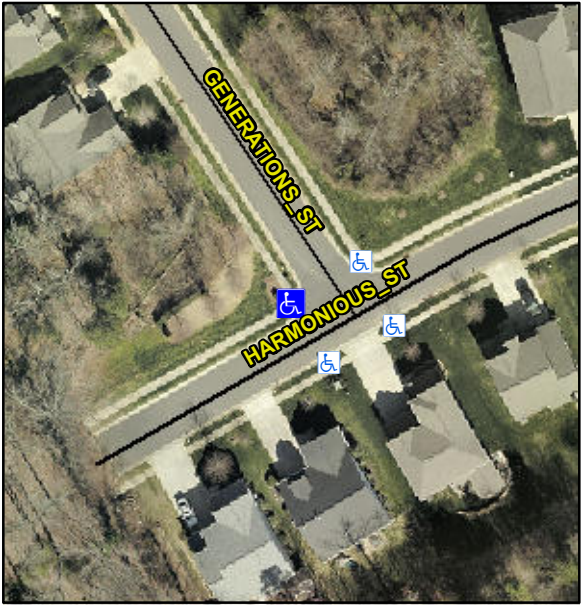
Possible Solutions:		Compliance	Description	Data
	Remove & Replace Curb Ramp With Two New Directional Ramps or Equivalent.		No	Ramp Length (in)	49.0
			Yes	Ramp Width (in)	48.0
			N/A	Flare Type LT	N/A
			N/A	Flare Slope LT (%)	N/A
			N/A	Flare Traversable LT?	N/A
			N/A	Landing Length (in)	N/A
			N/A	Landing Width (in)	N/A
			N/A	Landing Slope (%)	N/A
			N/A	Landing X Slope (%)	N/A
<p>Surveyor Notes:</p> <p>N/A</p> <p>PROW/ADA:</p> <p>R304.2.2, R304.5.3</p>			N/A	Flare Type RT	N/A
			N/A	Flare Slope RT (%)	N/A
			N/A	Flare Traversable RT?	N/A
			N/A	DWS Provided?	N/A
			N/A	DWS Contrast?	N/A
			N/A	DWS Length (in)	N/A
			N/A	DWS Full Width?	N/A
			N/A	DWS Offset (in)	N/A
			N/A	Gutter Ponding?	N/A
			N/A	Gutter Lip Ht (in)	N/A
<p>Total Cost:</p> <p>\$ 3200.00</p>			No	Painted X Walk2?	No
			N/A	X Walk 1 Direction	To SE
			N/A	X Walk 1 Width (in)	N/A

N/A	X Walk 1 Slope (%)	7.4
			N/A	X Walk 1 X Slope (%)	4.2
			N/A	Ramp inside XWalk1?	N/A
			N/A	Road Slope (%)	9.6
			N/A	Road X Slope (%)	7.4
			N/A	Any Obstructions?	N/A
			N/A	Obstruction Type	N/A
			N/A	X Walk 2 Direction	To NE
			N/A	X Walk 2 Width (in)	N/A
			N/A	X Walk 2 Slope (%)	0.9
			N/A	X Walk 2 X Slope (%)	5.1
			N/A	Ramp inside XWalk2?	N/A
			N/A	Clear Space?	N/A
			N/A	Clear Space to XWalk (in)	N/A
			N/A	Storm Grate/Utility Hazard?	N/A
			N/A	Storm Grate/Utility Type	N/A
			N/A	Surface Condition? (G/P)	Good
