Access Compliance Report Public Rights-of-Way (Curb Ramps)

Intersection ID: 14678Main Street: E_W_T_HARRIS_BVCross Street: WALLACE_AVLocation: NWADA ID: D36E3D3DC61ERamp Type: PerpInitial Pass/Fail: Fail Overall Compliance: No Severity Score: 12.5

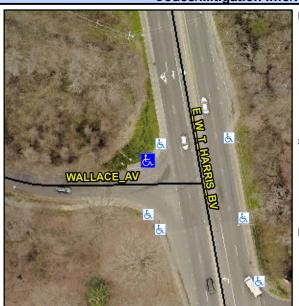
Not Found, R304.2.2

| Field Measurements/Component Compliance | | | | | |
|---|---|---|---|---|---|
| N/A | Ramp Length (in) | 59.5 | No | Ramp Slope (%) | 8.7 |

Remove & Replace Entire Ramp.
