Access Compliance Report Public Rights-of-Way (Curb Ramps)

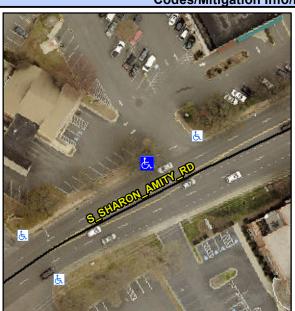
Intersection ID: 10036927 Main Street: S SHARON AMITY RD **Cross Street: N/A** Location: NW ADA ID: D3805C7AB5FC Ramp Type: PerpDiag Initial Pass/Fail: Fail **Overall Compliance: No** Severity Score: 46.25

S SHARON AMITY RD Street 1 Name Stop Condition-Street 2 Street 2 Name **ENTRANCE** Stop Condition-Street 1

Field Measurements/Component Compliance					
Compliance Description		Data	Comp	liance Description	Data
N/A	Ramp Length (in)	33.0	No	Ramp Slope (%)	8.7
No	Ramp Width (in)	46.0	No	Ramp XSlope (%)	7.0
N/A	Flare Type LT	N/A	N/A	Flare Type RT	N/A
N/A	Flare Slope LT (%)	N/A	N/A	Flare Slope RT (%)	N/A
N/A	Flare Traversable LT?	N/A	N/A	Flare Traversable RT?	N/A
N/A	Landing Length (in)	N/A	N/A	DWS Provided?	N/A
N/A	Landing Width (in)	N/A	N/A	DWS Contrast?	N/A
N/A	Landing Slope (%)	N/A	N/A	DWS Length (in)	N/A
N/A	Landing X Slope (%)	N/A	N/A	DWS Full Width?	N/A
N/A	Landing Curb? (Y/N)	N/A	N/A	DWS Offset (in)	N/A
N/A	Shared Landing?	N/A			
N/A	Gutter Ponding?	N/A	N/A	Gutter Slope (%)	N/A
N/A	Gutter Lip Ht (in)	N/A	N/A	Gutter X Slope (%)	N/A
N/A	Painted X Walk1?	No	N/A	Painted X Walk2?	No
	X Walk 1 Direction	To SE		X Walk 2 Direction	To NE
N/A	X Walk 1 Width (in)	N/A	N/A	X Walk 2 Width (in)	N/A
	X Walk 1 Slope (%)	1.7		X Walk 2 Slope (%)	4.5

X Walk 1 X Slope (%)	5.4		X Walk 2 X Slope (%)	3.1
N/A	Ramp inside XWalk1?	N/A	N/A	Ramp inside XWalk2?	N/A
	Road Slope (%)	5.0	N/A	Clear Space?	N/A
	Road X Slope (%)	4.1	N/A	Clear Space to XWalk (in)	N/A
N/A	Any Obstructions?	N/A	N/A	Storm Grate/Utility Hazard?	N/A
	Obstruction Type			Storm Grate/Utility Type	
		N/A			N/A
			Yes	Surface Condition? (G/P)	Good

Possible Solutions: **Remove & Replace Curb Ramp With Two New Directional Ramps or** Equivalent. Surveyor Notes: N/A PROW/ADA: Not Found, R304.5.1, R304.2.2, R304.5.3

3200.00

Total Cost:
