Access Compliance Report

Public Rights-of-Way

(Curb Ramps)

Intersection ID: 14311	Main Street: BERKELEY_AV	Cross Street: CARLTON_AV	Location:	N
ADA ID: D3832B3C548F	Ramp Type: Directional1	Initial Pass/Fail: Fail	Overall Compliance: No	Severity Score: 25
Codes/Mitigation Info/Possible Solution		Field Measurements/Component Compliance

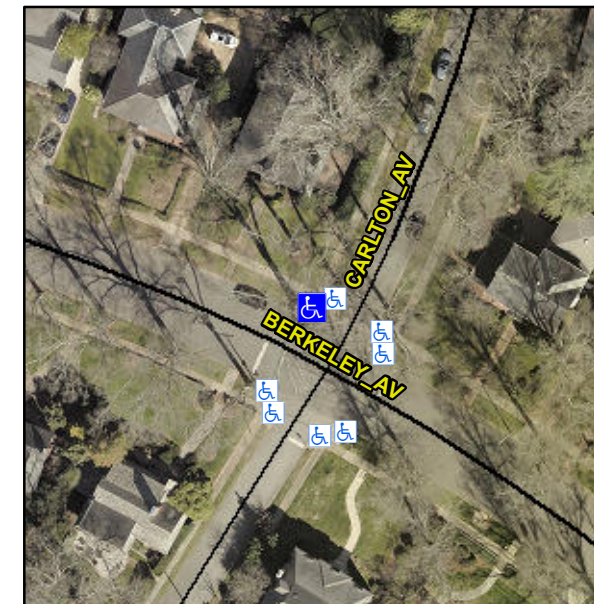
LNDG LIP 1.0"

R304.2.2, R304.5.3

Compliance	Description	Data	Compliance	Description	Data
N/A	Ramp Length (in)	84.0	N/A	Grade Break?	N/A
Yes	Ramp Width (in)	60.0	N/A	Grade Break Slope (%)	0.0
No	Ramp Slope (%)	8.5	N/A	Grade Break XSlope (%)	0.0
No	Ramp XSlope (%)	5.2			
N/A	Flare Type LT	N/A	N/A	Flare Type RT	N/A
N/A	Flare Slope LT (%)	N/A	N/A	Flare Slope RT (%)	0.0
N/A	Flare Traversable LT?	N/A	N/A	Flare Traversable RT?	N/A
N/A	Landing Length (in)	0.0	N/A	DWS Provided?	N/A
N/A	Landing Width (in)	0.0	N/A	DWS Contrast?	N/A
N/A	Landing Slope (%)	0.0	N/A	DWS Length (in)	N/A
N/A	Landing X Slope (%)	0.0	N/A	DWS Full Width?	N/A
N/A	Landing Curb? (Y/N)	N/A	N/A	DWS Offset LT (in)	N/A
N/A	Shared Landing?	N/A	N/A	DWS Offset RT (in)	N/A
N/A	Gutter Ponding?	0.0	N/A	Gutter Slope (%)	N/A
N/A	Gutter Lip Ht (in)	2.0	N/A	Gutter X Slope (%)	N/A
N/A	Painted X Walk1?	No		Road Slope (%)	3.5
	X Walk 1 Direction	To SW		Road X Slope (%)	4.6
	X Walk 1 Width (in)	N/A		Clear Space?	N/A

X Walk 1 Slope (%)	3.5	N/A	Clear Space to XWalk (in)	N/A
	X Walk 1 X Slope (%)	4.6	N/A	Storm Grate/Utility Hazard?	N/A
N/A	Ramp inside XWalk1?	N/A		Storm Grate/Utility Type	
N/A	Any Obstructions?	N/A			N/A
	Obstruction Type		Yes	Surface Condition? (G/P)	Good
			N/A	Curb Slope (%)	11.2

Possible Solutions:

Remove & Replace Entire Ramp.

Total Cost: \$ 1600.00
