# Access Compliance Report

## Public Rights-of-Way

### (Curb Ramps)

Intersection ID: 11285	Main Street: AVENSONG_CROSSING_DR	Cross Street: CHANTRESS_LN	Location: NW
ADA ID: D38C0869FCA8	Ramp Type: BlendTrans1	Initial Pass/Fail: Fail	Overall Compliance: No
Severity Score: 8.75			
Codes/Mitigation Info/Possible Solution		Field Measurements/Component Compliance

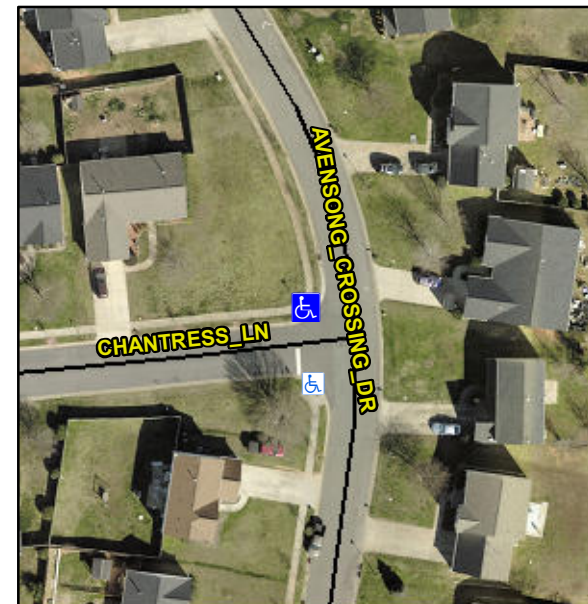
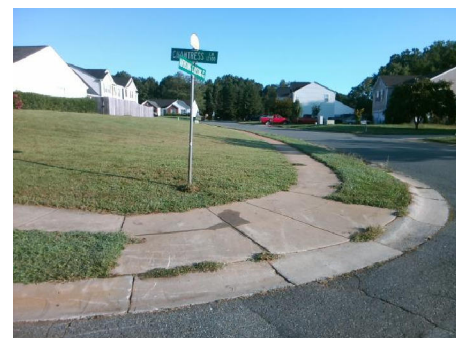
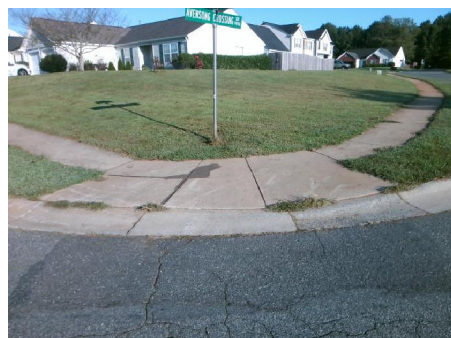
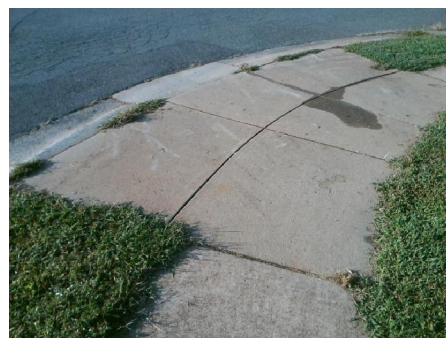
Compliance	Description	Data	Compliance	Description	Data
N/A	Ramp Length (in)	45.5	Yes	BlendTrans Slope (%)	4.5
No	Ramp Width (in)	38.5	Yes	BlendTrans XSlope (%)	0.2
N/A	Flare Type LT	N/A	N/A	Flare Type RT	N/A
N/A	Flare Slope LT (%)	N/A	N/A	Flare Slope RT (%)	N/A
N/A	Flare Traversable LT?	N/A	N/A	Flare Traversable RT?	N/A
N/A	Landing Length (in)	N/A	N/A	DWS Provided?	N/A
N/A	Landing Width (in)	N/A	N/A	DWS Contrast?	N/A
N/A	Landing Slope (%)	N/A	N/A	DWS Length (in)	N/A
N/A	Landing X Slope (%)	N/A	N/A	DWS Full Width?	N/A
N/A	Landing Curb? (Y/N)	N/A	N/A	DWS Offset (in)	N/A
N/A	Shared Landing?	N/A			
N/A	Gutter Ponding?	N/A	N/A	Gutter Slope (%)	N/A
N/A	Gutter Lip Ht (in)	N/A	N/A	Gutter X Slope (%)	N/A
N/A	Painted X Walk1?	No	N/A	Painted X Walk2?	N/A
	X Walk 1 Direction	To S		X Walk 2 Direction	N/A
	X Walk 1 Width (in)	N/A		X Walk 2 Width (in)	N/A
	X Walk 1 Slope (%)	1.5		X Walk 2 Slope (%)	N/A
	X Walk 1 X Slope (%)	0.2		X Walk 2 X Slope (%)	N/A

N/A	Ramp inside XWalk1?	N/A	N/A	Ramp inside XWalk2?	N/A
	Road Slope (%)	0.2		Clear Space?	N/A
	Road X Slope (%)	1.5	N/A	Clear Space to XWalk (in)	N/A
N/A	Any Obstructions?	N/A	N/A	Storm Grate/Utility Hazard?	N/A
	Obstruction Type			Storm Grate/Utility Type	
		N/A			N/A
			Yes	Surface Condition? (G/P)	Good
			No	Curb Slope (%)	9.9

Possible Solutions:

**Remove & Replace Curb Ramp With Two New Directional Ramps or Equivalent.**
