# Access Compliance Report

## Public Rights-of-Way

Intersection ID: 50441	Main Street: ALICE_MCGINN_DR	Cross Street: COPPER_MOUNTAIN_BV	Location: SW
ADA ID: D3B1D714DF90	Ramp Type: PerpDiag	Initial Pass/Fail: Fail	Overall Compliance: No
		Severity Score: 25

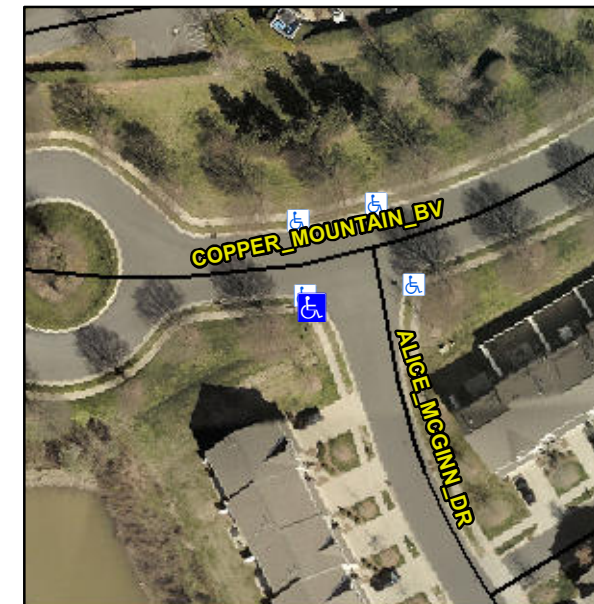
**Not Found, R304.5.3**

Compliance	Description	Data	Compliance	Description	Data
N/A	Ramp Length (in)	46.0	Yes	Ramp Slope (%)	5.5
Yes	Ramp Width (in)	48.0	No	Ramp XSlope (%)	8.8
N/A	Flare Type LT	N/A	N/A	Flare Type RT	N/A
N/A	Flare Slope LT (%)	N/A	N/A	Flare Slope RT (%)	N/A
N/A	Flare Traversable LT?	N/A	N/A	Flare Traversable RT?	N/A
N/A	Landing Length (in)	N/A	N/A	DWS Provided?	N/A
N/A	Landing Width (in)	N/A	N/A	DWS Contrast?	N/A
N/A	Landing Slope (%)	N/A	N/A	DWS Length (in)	N/A
N/A	Landing X Slope (%)	N/A	N/A	DWS Full Width?	N/A
N/A	Landing Curb? (Y/N)	N/A	N/A	DWS Offset (in)	N/A
N/A	Shared Landing?	N/A			
N/A	Gutter Ponding?	N/A	N/A	Gutter Slope (%)	N/A
N/A	Gutter Lip Ht (in)	N/A	N/A	Gutter X Slope (%)	N/A
N/A	Painted X Walk1?	No	N/A	Painted X Walk2?	No
	X Walk 1 Direction	To E		X Walk 2 Direction	To N
N/A	X Walk 1 Width (in)	N/A	N/A	X Walk 2 Width (in)	N/A
	X Walk 1 Slope (%)	0.8		X Walk 2 Slope (%)	4.8
	X Walk 1 X Slope (%)	0.7		X Walk 2 X Slope (%)	4.5

N/A	Ramp inside XWalk1?	N/A	N/A	Ramp inside XWalk2?	N/A
	Road Slope (%)	2.8	N/A	Clear Space?	N/A
	Road X Slope (%)	4.0	N/A	Clear Space to XWalk (in)	N/A
N/A	Any Obstructions?	N/A	N/A	Storm Grate/Utility Hazard?	N/A
	Obstruction Type			Storm Grate/Utility Type	
		N/A			N/A
			Yes	Surface Condition? (G/P)	Good

**Remove & Replace Curb Ramp With Two New Directional Ramps or Equivalent.**
