Access Compliance Report

Public Rights-of-Way

(Curb Ramps)

Intersection ID: 45096	Main Street: E_9TH_ST	Cross Street: N_DAVIDSON_ST	Location: E
ADA ID: D3BEA379E97E	Ramp Type: MedianPerp	Initial Pass/Fail: Fail	Overall Compliance: No
			Severity Score: 13.75

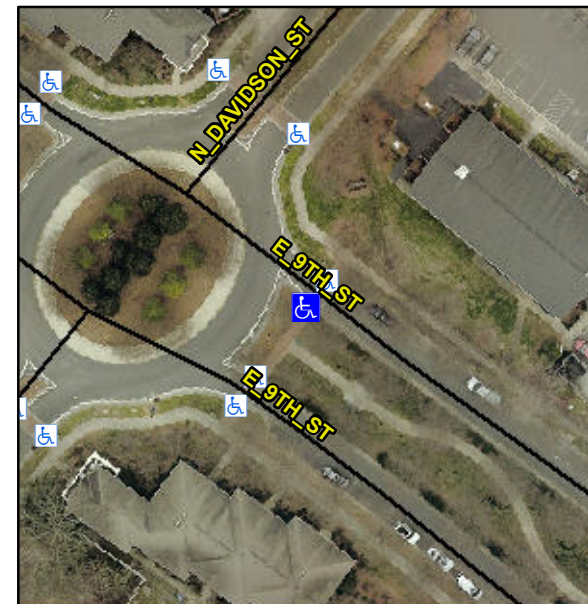
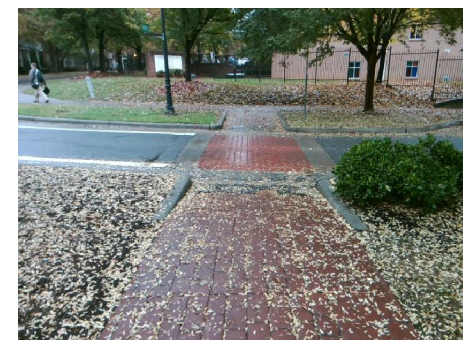
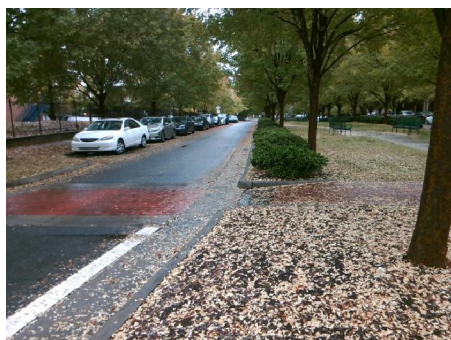
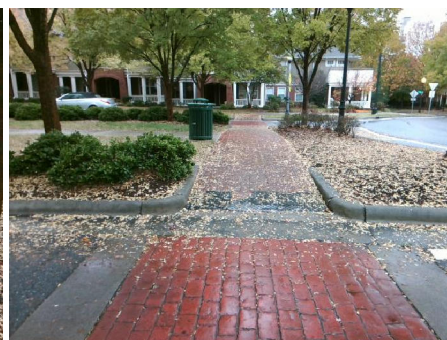
Not Found, R304.2.2, R304.5.3

Compliance	Description	Data	Compliance	Description	Data
N/A	Ramp Length (in)	70.0	No	Ramp Slope (%)	9.5
Yes	Ramp Width (in)	71.0	No	Ramp XSlope (%)	2.8
N/A	Flare Type LT	N/A	N/A	Flare Type RT	N/A
N/A	Flare Slope LT (%)	N/A	N/A	Flare Slope RT (%)	N/A
N/A	Flare Traversable LT?	N/A	N/A	Flare Traversable RT?	N/A
N/A	Landing Length (in)	N/A	N/A	DWS Provided?	N/A
N/A	Landing Width (in)	N/A	N/A	DWS Contrast?	N/A
N/A	Landing Slope (%)	N/A	N/A	DWS Length (in)	N/A
N/A	Landing X Slope (%)	N/A	N/A	DWS Full Width?	N/A
N/A	Landing Curb? (Y/N)	N/A	N/A	DWS Offset (in)	N/A
N/A	Shared Landing?	N/A			
N/A	Gutter Ponding?	Yes	N/A	Gutter Slope (%)	N/A
N/A	Gutter Lip Ht (in)	N/A	N/A	Gutter X Slope (%)	N/A
N/A	Painted X Walk1?	Yes	N/A	Painted X Walk2?	N/A
	X Walk 1 Direction	To NE		X Walk 2 Direction	N/A
N/A	X Walk 1 Width (in)	82.0	N/A	X Walk 2 Width (in)	N/A
	X Walk 1 Slope (%)	1.2		X Walk 2 Slope (%)	N/A
	X Walk 1 X Slope (%)	2.6		X Walk 2 X Slope (%)	N/A

N/A	Ramp inside XWalk1?	Yes	N/A	Ramp inside XWalk2?	N/A
	Road Slope (%)	N/A	N/A	Clear Space?	N/A
	Road X Slope (%)	N/A	N/A	Clear Space to XWalk (in)	N/A
N/A	Any Obstructions?	N/A	N/A	Storm Grate/Utility Hazard?	N/A
	Obstruction Type			Storm Grate/Utility Type	
		N/A			N/A
			Yes	Surface Condition? (G/P)	Good

Remove & Replace Entire Ramp.
