## **Access Compliance Report Public Rights-of-Way** (Curb Ramps)

Intersection ID: 46931 Main Street: SYCAMORE GROVE CT Cross Street: LIVERMORE\_LN Location: NW ADA ID: D3C152C82CC0 Ramp Type: PerpDiag Initial Pass/Fail: Fail **Overall Compliance: No Severity Score:** 8.75

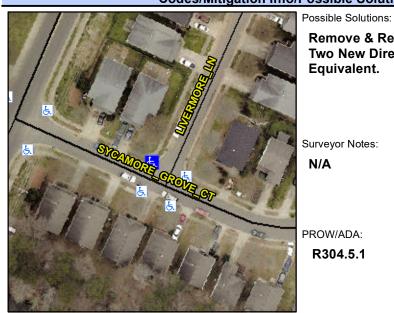
Comp	liance Description	Data		pliance Description	Data
N/A	Ramp Length (in)	47.0	Yes	Ramp Slope (%)	5.3
No	Ramp Width (in)	42.0	Yes	Ramp XSlope (%)	1.2
N/A	Flare Type LT	N/A	N/A	Flare Type RT	N/A
N/A	Flare Slope LT (%)	N/A	N/A	Flare Slope RT (%)	N/A
N/A	Flare Traversable LT?	N/A	N/A	Flare Traversable RT?	N/A
N/A	Landing Length (in)	N/A	N/A	DWS Provided?	N/A
N/A	Landing Width (in)	N/A	N/A	DWS Contrast?	N/A
N/A	Landing Slope (%)	N/A	N/A	DWS Length (in)	N/A
N/A	Landing X Slope (%)	N/A	N/A	DWS Full Width?	N/A
N/A	Landing Curb? (Y/N)	N/A	N/A	DWS Offset (in)	N/A
N/A	Shared Landing?	N/A			
N/A	Gutter Ponding?	N/A	N/A	Gutter Slope (%)	N/A
N/A	Gutter Lip Ht (in)	N/A	N/A	Gutter X Slope (%)	N/A
N/A	Painted X Walk1?	No	N/A	Painted X Walk2?	No
	X Walk 1 Direction	To SW		X Walk 2 Direction	To SE
N/A	X Walk 1 Width (in)	N/A	N/A	X Walk 2 Width (in)	N/A
	X Walk 1 Slope (%)	2.6		X Walk 2 Slope (%)	2.8
	X Walk 1 X Slope (%)	1.4		X Walk 2 X Slope (%)	1.5

N/A	Ramp inside XWalk1?	N/A	N/A	Ramp inside XWalk2?	N/A
	Road Slope (%)	2.7	N/A	Clear Space?	N/A
	Road X Slope (%)	5.5	N/A	Clear Space to XWalk (in)	N/A
N/A	Any Obstructions?	N/A	N/A	Storm Grate/Utility Hazard?	N/A
	Obstruction Type			Storm Grate/Utility Type	
		N/A			N/A
			Yes	Surface Condition? (G/P)	Good

**Remove & Replace Curb Ramp With Two New Directional Ramps or** Equivalent.

PROW/ADA:		
R304.5.1		
Total Cost:	\$	3200.00
