# Access Compliance Report

## Public Rights-of-Way

### (Curb Ramps)

Intersection ID: 50607	Main Street: DENBUR_DR	Cross Street: STREAM_ORCHID_LN	Location: SW
ADA ID: D3CB4F9E900F	Ramp Type: Perp	Initial Pass/Fail: Fail	Overall Compliance: No
Severity Score: 10			
Codes/Mitigation Info/Possible Solution		Field Measurements/Component Compliance

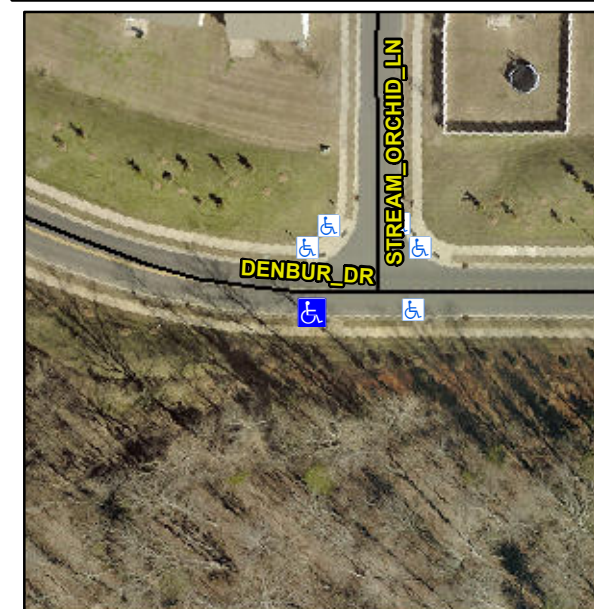
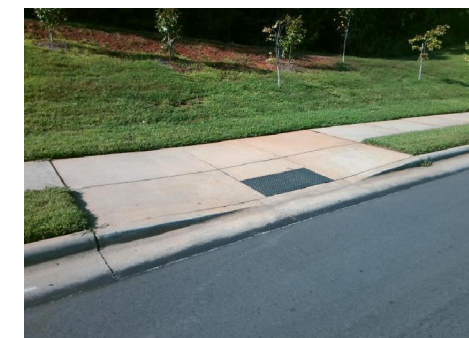
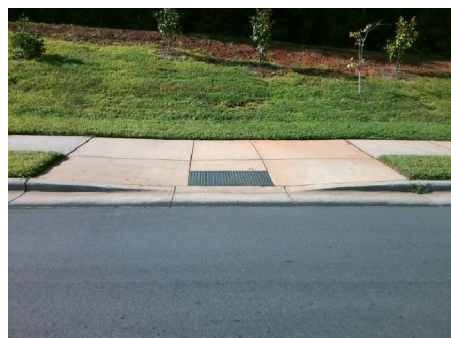
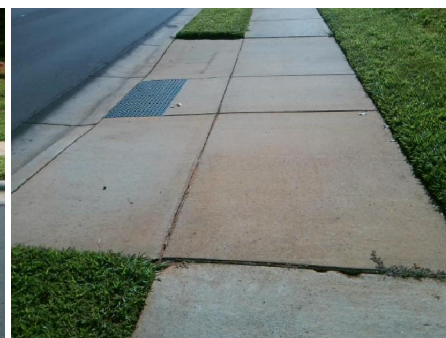
**Not Found, R304.5.1**

Compliance	Description	Data	Compliance	Description	Data
N/A	Ramp Length (in)	47.0	Yes	Ramp Slope (%)	7.8
No	Ramp Width (in)	47.5	Yes	Ramp XSlope (%)	2.1
N/A	Flare Type LT	N/A	N/A	Flare Type RT	N/A
N/A	Flare Slope LT (%)	N/A	N/A	Flare Slope RT (%)	N/A
N/A	Flare Traversable LT?	N/A	N/A	Flare Traversable RT?	N/A
N/A	Landing Length (in)	N/A	N/A	DWS Provided?	N/A
N/A	Landing Width (in)	N/A	N/A	DWS Contrast?	N/A
N/A	Landing Slope (%)	N/A	N/A	DWS Length (in)	N/A
N/A	Landing X Slope (%)	N/A	N/A	DWS Full Width?	N/A
N/A	Landing Curb? (Y/N)	N/A	N/A	DWS Offset (in)	N/A
N/A	Shared Landing?	N/A			
N/A	Gutter Ponding?	N/A	N/A	Gutter Slope (%)	N/A
N/A	Gutter Lip Ht (in)	N/A	N/A	Gutter X Slope (%)	N/A
N/A	Painted X Walk1?	No	N/A	Painted X Walk2?	N/A
	X Walk 1 Direction	To N		X Walk 2 Direction	N/A
N/A	X Walk 1 Width (in)	N/A	N/A	X Walk 2 Width (in)	N/A
	X Walk 1 Slope (%)	2.8		X Walk 2 Slope (%)	N/A
	X Walk 1 X Slope (%)	3.0		X Walk 2 X Slope (%)	N/A

N/A	Ramp inside XWalk1?	N/A	N/A	Ramp inside XWalk2?	N/A
	Road Slope (%)	N/A	N/A	Clear Space?	N/A
	Road X Slope (%)	N/A	N/A	Clear Space to XWalk (in)	N/A
N/A	Any Obstructions?	N/A	N/A	Storm Grate/Utility Hazard?	N/A
	Obstruction Type			Storm Grate/Utility Type	
		N/A			N/A
		Yes		Surface Condition? (G/P)	Good

**Remove & Replace Entire Ramp.**

Total Cost: \$ 1850.00
