# Access Compliance Report

## Public Rights-of-Way

### (Curb Ramps)

Intersection ID: 29760	Main Street: CREEK_POINTE_DR	Cross Street: FAWN_HILL_RD	Location: NE
ADA ID: D3DF897F43F4	Ramp Type: Perp	Initial Pass/Fail: Fail	Overall Compliance: No
Severity Score: 10			
Codes/Mitigation Info/Possible Solution		Field Measurements/Component Compliance

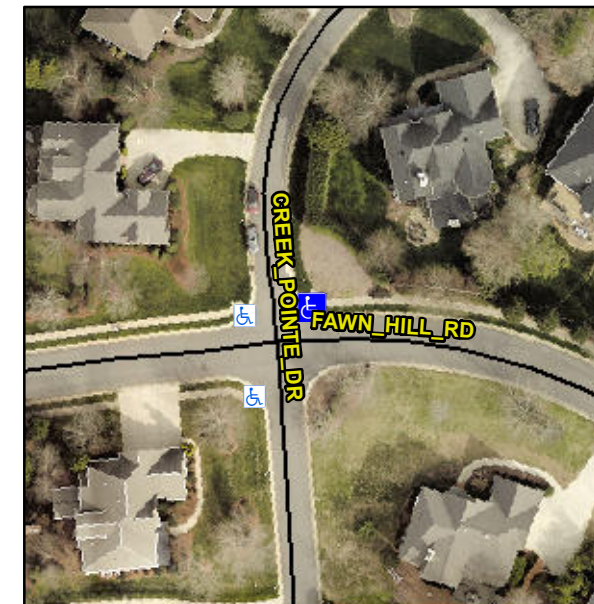
**Not Found, R304.5.1, R304.5.3**

Compliance	Description	Data	Compliance	Description	Data
N/A	Ramp Length (in)	46.5	Yes	Ramp Slope (%)	7.9
No	Ramp Width (in)	43.0	No	Ramp XSlope (%)	2.3
N/A	Flare Type LT	N/A	N/A	Flare Type RT	N/A
N/A	Flare Slope LT (%)	N/A	N/A	Flare Slope RT (%)	N/A
N/A	Flare Traversable LT?	N/A	N/A	Flare Traversable RT?	N/A
N/A	Landing Length (in)	N/A	N/A	DWS Provided?	N/A
N/A	Landing Width (in)	N/A	N/A	DWS Contrast?	N/A
N/A	Landing Slope (%)	N/A	N/A	DWS Length (in)	N/A
N/A	Landing X Slope (%)	N/A	N/A	DWS Full Width?	N/A
N/A	Landing Curb? (Y/N)	N/A	N/A	DWS Offset (in)	N/A
N/A	Shared Landing?	N/A			
N/A	Gutter Ponding?	N/A	N/A	Gutter Slope (%)	N/A
N/A	Gutter Lip Ht (in)	N/A	N/A	Gutter X Slope (%)	N/A
N/A	Painted X Walk1?	No	N/A	Painted X Walk2?	N/A
	X Walk 1 Direction	To W		X Walk 2 Direction	N/A
N/A	X Walk 1 Width (in)	N/A	N/A	X Walk 2 Width (in)	N/A
	X Walk 1 Slope (%)	2.7		X Walk 2 Slope (%)	N/A
	X Walk 1 X Slope (%)	1.3		X Walk 2 X Slope (%)	N/A

N/A	Ramp inside XWalk1?	N/A	N/A	Ramp inside XWalk2?	N/A
	Road Slope (%)	N/A	N/A	Clear Space?	N/A
	Road X Slope (%)	N/A	N/A	Clear Space to XWalk (in)	N/A
N/A	Any Obstructions?	N/A	N/A	Storm Grate/Utility Hazard?	N/A
	Obstruction Type			Storm Grate/Utility Type	
		N/A			N/A
			Yes	Surface Condition? (G/P)	Good

**Remove & Replace Entire Ramp.**

Total Cost: \$ 1850.00
