Access Compliance Report

Public Rights-of-Way

(Curb Ramps)

Intersection ID: 13947	Main Street: CHERRY_ST	Cross Street: E_1ST_ST	Location: SW
ADA ID: D3DFD928CB2D	Ramp Type: PerpDiag	Initial Pass/Fail: Fail	Overall Compliance: No
			Severity Score: 33.75

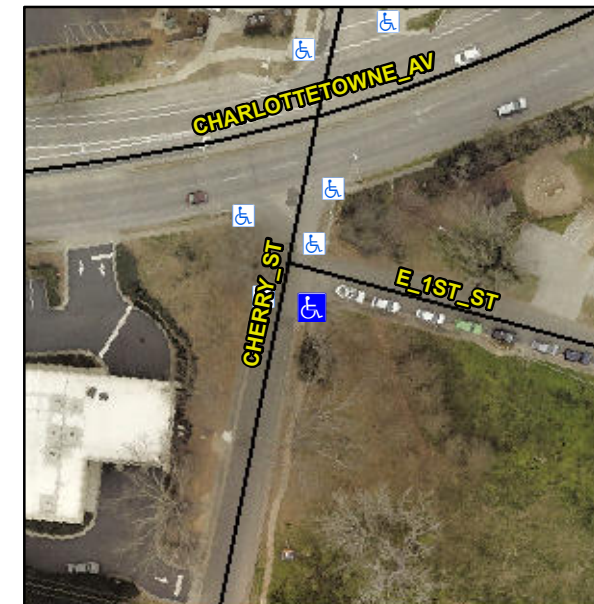
Not Found, R304.5.1, R304.2.2, R304.5.3

Compliance	Description	Data	Compliance	Description	Data
N/A	Ramp Length (in)	61.0	No	Ramp Slope (%)	9.2
No	Ramp Width (in)	37.0	No	Ramp XSlope (%)	5.7
N/A	Flare Type LT	N/A	N/A	Flare Type RT	N/A
N/A	Flare Slope LT (%)	N/A	N/A	Flare Slope RT (%)	N/A
N/A	Flare Traversable LT?	N/A	N/A	Flare Traversable RT?	N/A
N/A	Landing Length (in)	N/A	N/A	DWS Provided?	N/A
N/A	Landing Width (in)	N/A	N/A	DWS Contrast?	N/A
N/A	Landing Slope (%)	N/A	N/A	DWS Length (in)	N/A
N/A	Landing X Slope (%)	N/A	N/A	DWS Full Width?	N/A
N/A	Landing Curb? (Y/N)	N/A	N/A	DWS Offset (in)	N/A
N/A	Shared Landing?	N/A			
N/A	Gutter Ponding?	N/A	N/A	Gutter Slope (%)	N/A
N/A	Gutter Lip Ht (in)	N/A	N/A	Gutter X Slope (%)	N/A
N/A	Painted X Walk1?	No	N/A	Painted X Walk2?	No
	X Walk 1 Direction	To NE		X Walk 2 Direction	To NW
N/A	X Walk 1 Width (in)	N/A	N/A	X Walk 2 Width (in)	N/A
	X Walk 1 Slope (%)	3.2		X Walk 2 Slope (%)	1.3
	X Walk 1 X Slope (%)	2.2		X Walk 2 X Slope (%)	3.0

N/A	Ramp inside XWalk1?	N/A	N/A	Ramp inside XWalk2?	N/A
	Road Slope (%)	3.4	N/A	Clear Space?	N/A
	Road X Slope (%)	0.1	N/A	Clear Space to XWalk (in)	N/A
N/A	Any Obstructions?	N/A	N/A	Storm Grate/Utility Hazard?	N/A
	Obstruction Type			Storm Grate/Utility Type	
		N/A			N/A
			Yes	Surface Condition? (G/P)	Good

Remove & Replace Curb Ramp With Two New Directional Ramps or Equivalent.

Total Cost: \$ 3200.00
