Access Compliance Report

Public Rights-of-Way

(Curb Ramps)

Intersection ID: N/A	Main Street: DELTA_CROSSING_LN	Cross Street: W_T_HARRIS_BV	Location: SW
ADA ID: D3E434BC2EF2	Ramp Type: PerpDiag	Initial Pass/Fail: Fail	Overall Compliance: No
		Severity Score: 22.5

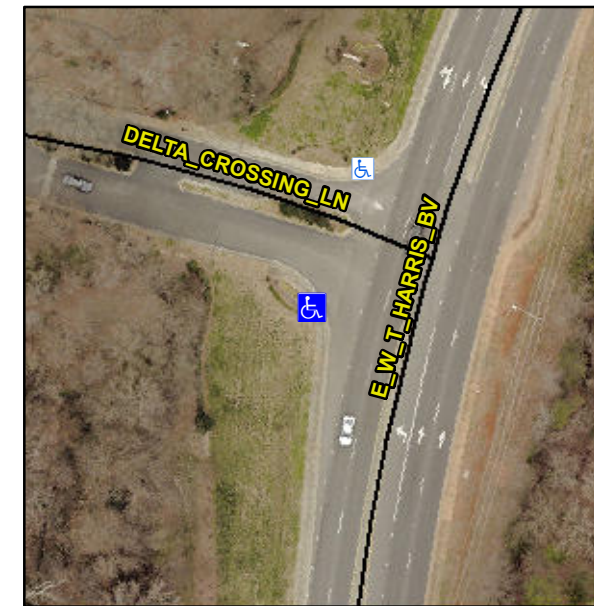
Compliance	Description	Data	Compliance	Description	Data
N/A	Ramp Length (in)	60.0	No	Ramp Slope (%)	10.6
No	Ramp Width (in)	43.0	No	Ramp XSlope (%)	4.5
N/A	Flare Type LT	N/A	N/A	Flare Type RT	N/A
N/A	Flare Slope LT (%)	N/A	N/A	Flare Slope RT (%)	N/A
N/A	Flare Traversable LT?	N/A	N/A	Flare Traversable RT?	N/A
N/A	Landing Length (in)	N/A	N/A	DWS Provided?	N/A
N/A	Landing Width (in)	N/A	N/A	DWS Contrast?	N/A
N/A	Landing Slope (%)	N/A	N/A	DWS Length (in)	N/A
N/A	Landing X Slope (%)	N/A	N/A	DWS Full Width?	N/A
N/A	Landing Curb? (Y/N)	N/A	N/A	DWS Offset (in)	N/A
N/A	Shared Landing?	N/A			
N/A	Gutter Ponding?	N/A	N/A	Gutter Slope (%)	N/A
N/A	Gutter Lip Ht (in)	N/A	N/A	Gutter X Slope (%)	N/A
N/A	Painted X Walk1?	No	N/A	Painted X Walk2?	No
	X Walk 1 Direction	To SE		X Walk 2 Direction	To NE
N/A	X Walk 1 Width (in)	N/A	N/A	X Walk 2 Width (in)	N/A
	X Walk 1 Slope (%)	3.6		X Walk 2 Slope (%)	0.6
	X Walk 1 X Slope (%)	1.5		X Walk 2 X Slope (%)	3.1

N/A	Ramp inside XWalk1?	N/A	N/A	Ramp inside XWalk2?	N/A
	Road Slope (%)	2.9	N/A	Clear Space?	N/A
	Road X Slope (%)	3.4	N/A	Clear Space to XWalk (in)	N/A
N/A	Any Obstructions?	N/A	N/A	Storm Grate/Utility Hazard?	N/A
	Obstruction Type			Storm Grate/Utility Type	
		N/A			N/A
			Yes	Surface Condition? (G/P)	Good

Remove & Replace Curb Ramp With Two New Directional Ramps or Equivalent.

R304.5.1, R304.2.2, R304.5.3
