Access Compliance Report

Public Rights-of-Way

(Curb Ramps)

Intersection ID: 21614	Main Street: RITTENHOUSE_CR	Cross Street: SARDIS_RD_NORTH	Location: SE
ADA ID: D3F9C513804B	Ramp Type: PerpDiag	Initial Pass/Fail: Fail	Overall Compliance: No
		Severity Score: 35

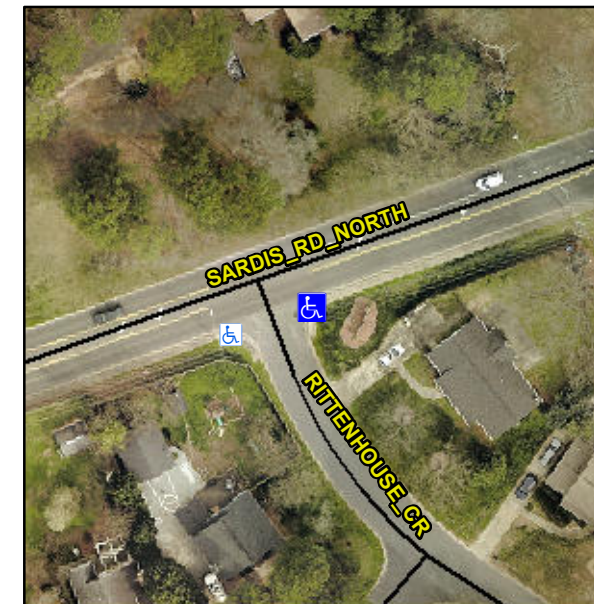
Not Found, R304.5.1, R304.2.2, R304.5.3

Compliance	Description	Data	Compliance	Description	Data
N/A	Ramp Length (in)	48.0	No	Ramp Slope (%)	12.6
No	Ramp Width (in)	44.0	No	Ramp XSlope (%)	4.3
N/A	Flare Type LT	N/A	N/A	Flare Type RT	N/A
N/A	Flare Slope LT (%)	N/A	N/A	Flare Slope RT (%)	N/A
N/A	Flare Traversable LT?	N/A	N/A	Flare Traversable RT?	N/A
N/A	Landing Length (in)	N/A	N/A	DWS Provided?	N/A
N/A	Landing Width (in)	N/A	N/A	DWS Contrast?	N/A
N/A	Landing Slope (%)	N/A	N/A	DWS Length (in)	N/A
N/A	Landing X Slope (%)	N/A	N/A	DWS Full Width?	N/A
N/A	Landing Curb? (Y/N)	N/A	N/A	DWS Offset (in)	N/A
N/A	Shared Landing?	N/A			
N/A	Gutter Ponding?	N/A	N/A	Gutter Slope (%)	N/A
N/A	Gutter Lip Ht (in)	N/A	N/A	Gutter X Slope (%)	N/A
N/A	Painted X Walk1?	No	N/A	Painted X Walk2?	No
	X Walk 1 Direction	To N		X Walk 2 Direction	To W
N/A	X Walk 1 Width (in)	N/A	N/A	X Walk 2 Width (in)	N/A
	X Walk 1 Slope (%)	4.0		X Walk 2 Slope (%)	4.2
	X Walk 1 X Slope (%)	3.3		X Walk 2 X Slope (%)	3.3

N/A	Ramp inside XWalk1?	N/A	N/A	Ramp inside XWalk2?	N/A
	Road Slope (%)	4.5	N/A	Clear Space?	N/A
	Road X Slope (%)	1.5	N/A	Clear Space to XWalk (in)	N/A
N/A	Any Obstructions?	N/A	N/A	Storm Grate/Utility Hazard?	N/A
	Obstruction Type			Storm Grate/Utility Type	
		N/A			N/A
			Yes	Surface Condition? (G/P)	Good

Remove & Replace Curb Ramp With Two New Directional Ramps or Equivalent.
