# Access Compliance Report

## Public Rights-of-Way

### (Curb Ramps)

| Intersection ID: 10036062 | Main Street: RIVERGATE_PY | Cross Street: N/A | Location: NW |

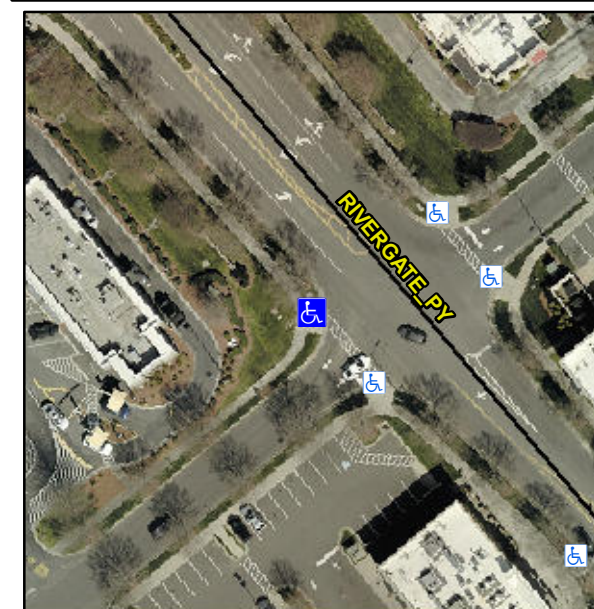
**Not Found, R304.5.1, R304.5.3**

| Compliance | Description | Data | Compliance | Description | Data |
|---|---|---|---|---|---|
| N/A | Ramp Length (in) | 97.0 | Yes | Ramp Slope (%) | 7.9 |
| No | Ramp Width (in) | 45.0 | No | Ramp XSlope (%) | 2.5 |

**Remove & Replace Curb Ramp With Two New Directional Ramps or Equivalent.**
