Access Compliance Report

Public Rights-of-Way

(Curb Ramps)

Intersection ID: 20296	Main Street: DINGESS_RD	Cross Street: LUNDALE_CT	Location: NE
ADA ID: D40B83CF669D	Ramp Type: PerpDiag	Initial Pass/Fail: Fail	Overall Compliance: No
Severity Score: 47.5			
Codes/Mitigation Info/Possible Solution		Field Measurements/Component Compliance

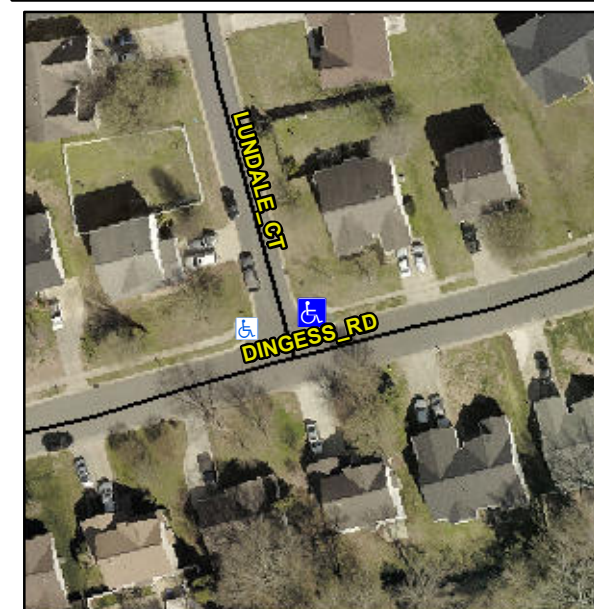
Compliance	Description	Data	Compliance	Description	Data
N/A	Ramp Length (in)	46.0	No	Ramp Slope (%)	10.7
No	Ramp Width (in)	31.0	Yes	Ramp XSlope (%)	0.2
N/A	Flare Type LT	N/A	N/A	Flare Type RT	N/A
N/A	Flare Slope LT (%)	N/A	N/A	Flare Slope RT (%)	N/A
N/A	Flare Traversable LT?	N/A	N/A	Flare Traversable RT?	N/A
N/A	Landing Length (in)	N/A	N/A	DWS Provided?	N/A
N/A	Landing Width (in)	N/A	N/A	DWS Contrast?	N/A
N/A	Landing Slope (%)	N/A	N/A	DWS Length (in)	N/A
N/A	Landing X Slope (%)	N/A	N/A	DWS Full Width?	N/A
N/A	Landing Curb? (Y/N)	N/A	N/A	DWS Offset (in)	N/A
N/A	Shared Landing?	N/A			
N/A	Gutter Ponding?	N/A	N/A	Gutter Slope (%)	N/A
N/A	Gutter Lip Ht (in)	N/A	N/A	Gutter X Slope (%)	N/A
N/A	Painted X Walk1?	No	N/A	Painted X Walk2?	No
	X Walk 1 Direction	To W		X Walk 2 Direction	To S
N/A	X Walk 1 Width (in)	N/A	N/A	X Walk 2 Width (in)	N/A
	X Walk 1 Slope (%)	0.6		X Walk 2 Slope (%)	1.3
	X Walk 1 X Slope (%)	1.0		X Walk 2 X Slope (%)	2.4

N/A	Ramp inside XWalk1?	N/A	N/A	Ramp inside XWalk2?	N/A
	Road Slope (%)	0.6	N/A	Clear Space?	N/A
	Road X Slope (%)	0.4	N/A	Clear Space to XWalk (in)	N/A
N/A	Any Obstructions?	N/A	N/A	Storm Grate/Utility Hazard?	N/A
	Obstruction Type			Storm Grate/Utility Type	
		N/A			N/A
			Yes	Surface Condition? (G/P)	Good

Remove & Replace Curb Ramp With Two New Directional Ramps or Equivalent.

R304.5.1, R304.2.2
