Access Compliance Report

Public Rights-of-Way

(Curb Ramps)

Intersection ID: 27760	Main Street: BALLANTYNE_COUNTRY_CLUB_DR	Cross Street: BALLANTYNE_CROSSING_AV	Location: SW
ADA ID: D40FC488685C	Ramp Type: Perp	Initial Pass/Fail: Fail	Overall Compliance: No
Severity Score: 12.5			
Codes/Mitigation Info/Possible Solution		Field Measurements/Component Compliance

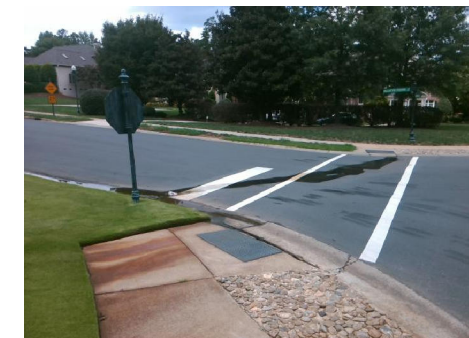
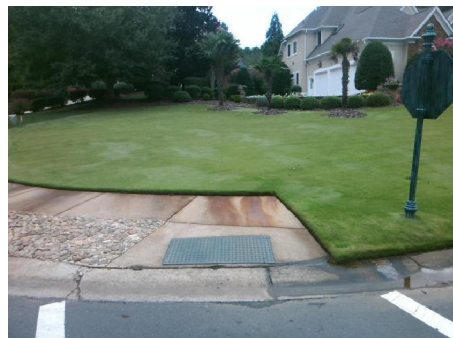
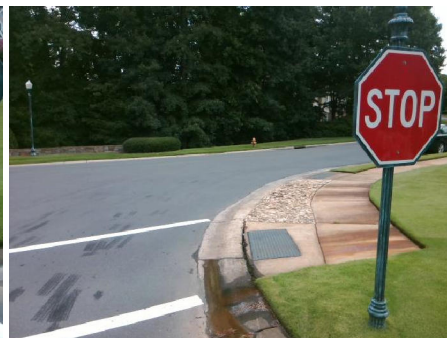
Not Found, R304.2.2

Compliance	Description	Data	Compliance	Description	Data
N/A	Ramp Length (in)	40.0	No	Ramp Slope (%)	11.7
Yes	Ramp Width (in)	48.0	Yes	Ramp XSlope (%)	1.3
N/A	Flare Type LT	N/A	N/A	Flare Type RT	N/A
N/A	Flare Slope LT (%)	N/A	N/A	Flare Slope RT (%)	N/A
N/A	Flare Traversable LT?	N/A	N/A	Flare Traversable RT?	N/A
N/A	Landing Length (in)	N/A	N/A	DWS Provided?	N/A
N/A	Landing Width (in)	N/A	N/A	DWS Contrast?	N/A
N/A	Landing Slope (%)	N/A	N/A	DWS Length (in)	N/A
N/A	Landing X Slope (%)	N/A	N/A	DWS Full Width?	N/A
N/A	Landing Curb? (Y/N)	N/A	N/A	DWS Offset (in)	N/A
N/A	Shared Landing?	N/A			
N/A	Gutter Ponding?	N/A	N/A	Gutter Slope (%)	N/A
N/A	Gutter Lip Ht (in)	N/A	N/A	Gutter X Slope (%)	N/A
N/A	Painted X Walk1?	Yes	N/A	Painted X Walk2?	N/A
	X Walk 1 Direction	To NE		X Walk 2 Direction	N/A
N/A	X Walk 1 Width (in)	102.0	N/A	X Walk 2 Width (in)	N/A
	X Walk 1 Slope (%)	4.7		X Walk 2 Slope (%)	N/A
	X Walk 1 X Slope (%)	0.9		X Walk 2 X Slope (%)	N/A

N/A	Ramp inside XWalk1?	Yes	N/A	Ramp inside XWalk2?	N/A
	Road Slope (%)	N/A	N/A	Clear Space?	N/A
	Road X Slope (%)	N/A	N/A	Clear Space to XWalk (in)	N/A
N/A	Any Obstructions?	N/A	N/A	Storm Grate/Utility Hazard?	N/A
	Obstruction Type			Storm Grate/Utility Type	
		N/A			N/A
		Yes		Surface Condition? (G/P)	Good

Remove & Replace Entire Ramp.
