Access Compliance Report Public Rights-of-Way (Curb Ramps)

Intersection ID: 11494 Main Street: BECKWITH_PL Cross Street: EAST_FORD_RD Location: N

ADA ID: D415FD7A3BC0 Ramp Type: BlendTrans1 Initial Pass/Fail: Fail Overall Compliance: No Severity Score: 25

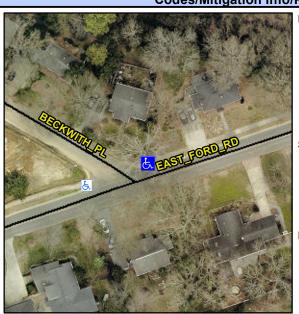
Not Found, R304.5.3

Field Measurements/Component Compliance					
Compliance Description Data		Compliance Description		Data	
N/A	Ramp Length (in)	74.0	Yes	BlendTrans Slope (%)	4.5
Yes	Ramp Width (in)	56.0	No	BlendTrans XSlope (%)	8.5
N/A	Flare Type LT	N/A	N/A	Flare Type RT	N/A
N/A	Flare Slope LT (%)	N/A	N/A	Flare Slope RT (%)	N/A
N/A	Flare Traversable LT?	N/A	N/A	Flare Traversable RT?	N/A
N/A	Landing Length (in)	N/A	N/A	DWS Provided?	N/A
N/A	Landing Width (in)	N/A	N/A	DWS Contrast?	N/A
N/A	Landing Slope (%)	N/A	N/A	DWS Length (in)	N/A
N/A	Landing X Slope (%)	N/A	N/A	DWS Full Width?	N/A
N/A	Landing Curb? (Y/N)	N/A	N/A	DWS Offset (in)	N/A
N/A	Shared Landing?	N/A			
N/A	Gutter Ponding?	N/A	N/A	Gutter Slope (%)	N/A
N/A	Gutter Lip Ht (in)	N/A	N/A	Gutter X Slope (%)	N/A
N/A	Painted X Walk1?	No	N/A	Painted X Walk2?	N/A
	X Walk 1 Direction	To SW		X Walk 2 Direction	N/A
	X Walk 1 Width (in)	N/A		X Walk 2 Width (in)	N/A
	X Walk 1 Slope (%)	6.4		X Walk 2 Slope (%)	N/A

X Walk 1 X Slope (%)	0.7		X Walk 2 X Slope (%)	N/A
N/A	Ramp inside XWalk1?	N/A	N/A	Ramp inside XWalk2?	N/A
	Road Slope (%)	0.7		Clear Space?	N/A
	Road X Slope (%)	6.4	N/A	Clear Space to XWalk (in)	N/A
N/A	Any Obstructions?	N/A	N/A	Storm Grate/Utility Hazard?	N/A
	Obstruction Type		l	Storm Grate/Utility Type	
		N/A	l		N/A
			Yes	Surface Condition? (G/P)	Good
	San Caralla		No	Curb Slope (%)	17.5

Remove & Replace Curb Ramp With
Two New Directional Ramps or
Equivalent.
