Access Compliance Report

Public Rights-of-Way

(Curb Ramps)

Intersection ID: 11556	Main Street: HARRILL_ST	Cross Street: PARKWOOD_AV	Location: S
ADA ID: D41FE1B9B22D	Ramp Type: Combination1	Initial Pass/Fail: Fail	Overall Compliance: No
			Severity Score: 46.25

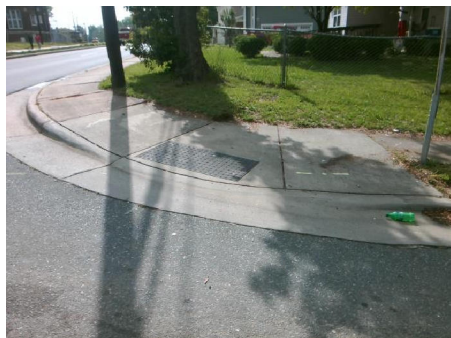
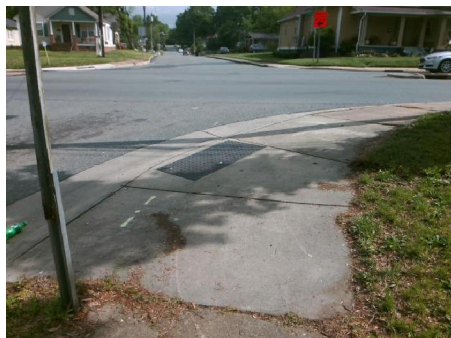
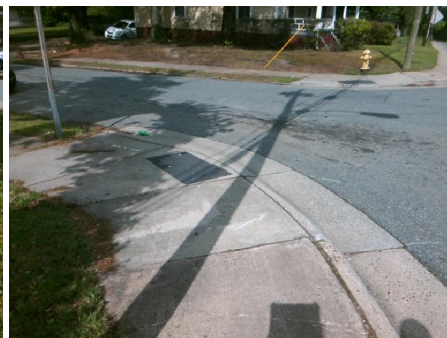
RP < 5%

**R304.5.1, R304.5.1, R304.5.3,
R304.3.2**

Compliance	Description	Data	Compliance	Description	Data
N/A	Ramp Length LT (in)	55.0	N/A	Ramp Length RT (in)	48.0
No	Ramp Width LT (in)	47.0	Yes	Ramp Width RT (in)	48.0
No	Ramp Slope LT (%)	10.9	No	Ramp Slope RT (%)	8.9
No	Ramp XSlope LT (%)	4.9	No	Ramp XSlope RT (%)	2.3
N/A	Ramp Length (in)	80.0	Yes	Ramp Slope (%)	3.1
No	Ramp Width (in)	36.0	No	Ramp XSlope (%)	9.5
N/A	Flare Type LT	N/A	N/A	Flare Type RT	N/A
N/A	Flare Slope LT (%)	N/A	N/A	Flare Slope RT (%)	N/A
N/A	Flare Traversable LT?	N/A	N/A	Flare Traversable RT?	N/A
N/A	Landing Length (in)	N/A	N/A	DWS Provided?	N/A
N/A	Landing Width (in)	N/A	N/A	DWS Contrast?	N/A
N/A	Landing Slope (%)	N/A	N/A	DWS Length (in)	N/A
N/A	Landing X Slope (%)	N/A	N/A	DWS Full Width?	N/A
N/A	Landing Curb? (Y/N)	N/A	N/A	DWS Offset (in)	N/A
N/A	Shared Landing?	N/A			
N/A	Gutter Ponding?	N/A	N/A	Gutter Slope (%)	N/A
N/A	Gutter Lip Ht (in)	N/A	N/A	Gutter X Slope (%)	N/A
N/A	Painted X Walk1?	No	N/A	Painted X Walk2?	N/A

Remove & Replace Entire Ramp.
