# Access Compliance Report

## Public Rights-of-Way

### (Curb Ramps)

Intersection ID: N/A	Main Street: SAM_NEELY_RD	Cross Street: STEELE_CREEK_RD	Location: NW
ADA ID: D433B755AEAE	Ramp Type: Perp	Initial Pass/Fail: Fail	Overall Compliance: No
		Severity Score: 12.5

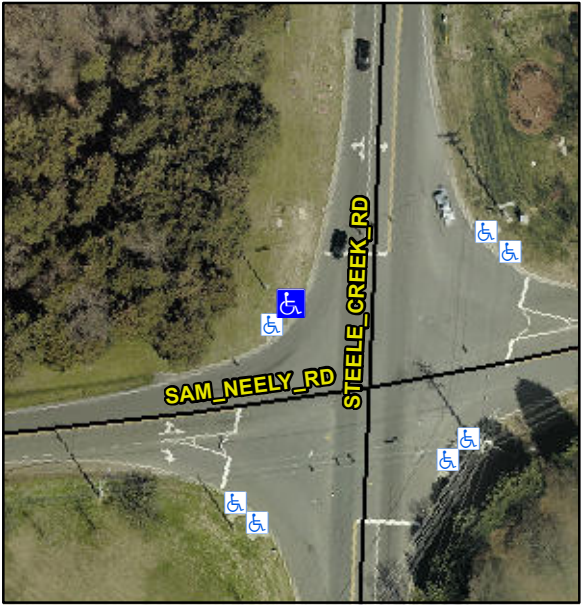
Possible Solutions:		<b>Compliance</b>	<b>Description</b>	<b>Data</b>
	<b>Remove &amp; Replace Entire Ramp.</b>		<b>No</b>	Ramp Length (in)	58.0
			<b>Yes</b>	Ramp Width (in)	48.0
			<b>N/A</b>	Flare Type LT	N/A
			<b>N/A</b>	Flare Slope LT (%)	N/A
			<b>N/A</b>	Flare Traversable LT?	N/A
			<b>N/A</b>	Landing Length (in)	N/A
			<b>N/A</b>	Landing Width (in)	N/A
			<b>N/A</b>	Landing Slope (%)	N/A
			<b>N/A</b>	Landing X Slope (%)	N/A
<p>Surveyor Notes:</p> <p><b>N/A</b></p> <p>PROW/ADA:</p> <p><b>Not Found, R304.2.2</b></p>			<b>N/A</b>	Flare Type RT	N/A
			<b>N/A</b>	Flare Slope RT (%)	N/A
			<b>N/A</b>	Flare Traversable RT?	N/A
			<b>N/A</b>	DWS Provided?	N/A
			<b>N/A</b>	DWS Contrast?	N/A
			<b>N/A</b>	DWS Length (in)	N/A
			<b>N/A</b>	DWS Full Width?	N/A
			<b>N/A</b>	DWS Offset (in)	N/A
			<b>N/A</b>	Shared Landing?	N/A

<b>N/A</b>	Gutter Ponding?	N/A
			<b>N/A</b>	Gutter Lip Ht (in)	N/A
			<b>No</b>	Painted X Walk1?	N/A
				X Walk 1 Direction	To E
			<b>N/A</b>	X Walk 1 Width (in)	N/A
				X Walk 1 Slope (%)	3.8
				X Walk 1 X Slope (%)	0.9
			<b>N/A</b>	Ramp inside XWalk1?	N/A
			<b>N/A</b>	Road Slope (%)	N/A
			<b>N/A</b>	Road X Slope (%)	N/A
			<b>N/A</b>	Any Obstructions?	N/A
				Obstruction Type	
			<b>N/A</b>		
			<b>N/A</b>		N/A
			<b>Yes</b>	Surface Condition? (G/P)	Good
