# Access Compliance Report

## Public Rights-of-Way

### (Curb Ramps)

| Intersection ID: 19453 | Main Street: ALDERSHOT_CT | Cross Street: KINGSGATE_PL | Location: SE |

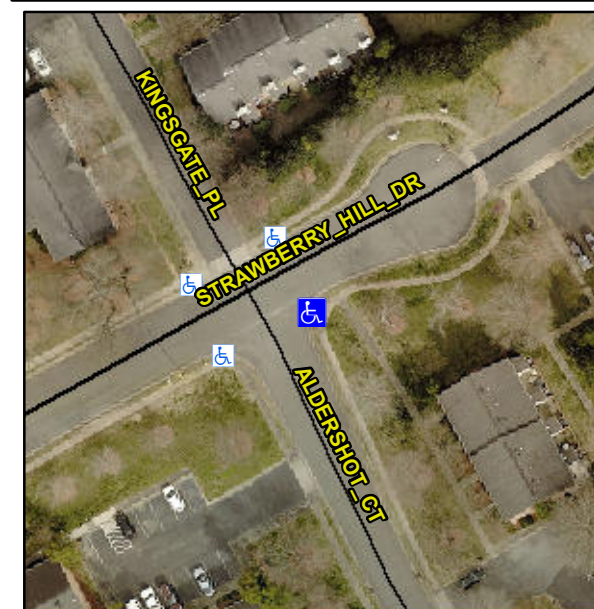
| ADA ID: D44ADD1F8BFE | Ramp Type: PerpDiag | Initial Pass/Fail: Fail | Overall Compliance: No |
| Severity Score: 13.75 | | | |

| Compliance | Description | Data | Compliance | Description | Data |
|---|---|---|---|---|---|
| N/A | Ramp Length (in) | 63.0 | No | Ramp Slope (%) | 8.5 |
| Yes | Ramp Width (in) | 48.0 | No | Ramp XSlope (%) | 4.3 |

**Remove & Replace Curb Ramp With Two New Directional Ramps or Equivalent.**

**R304.2.2, R304.5.3**

Total Cost: \$ 3200.00
