Access Compliance Report

Public Rights-of-Way

(Curb Ramps)

Intersection ID: 27440	Main Street: BALLANTYNE COMMONS PY	Cross Street: DOWINGTON DR	Location:	SW
ADA ID: D45001334F2B	Ramp Type: Perp	Initial Pass/Fail: Fail	Overall Compliance: No	Severity Score: 10
Codes/Mitigation Info/Possible Solution		Field Measurements/Component Compliance

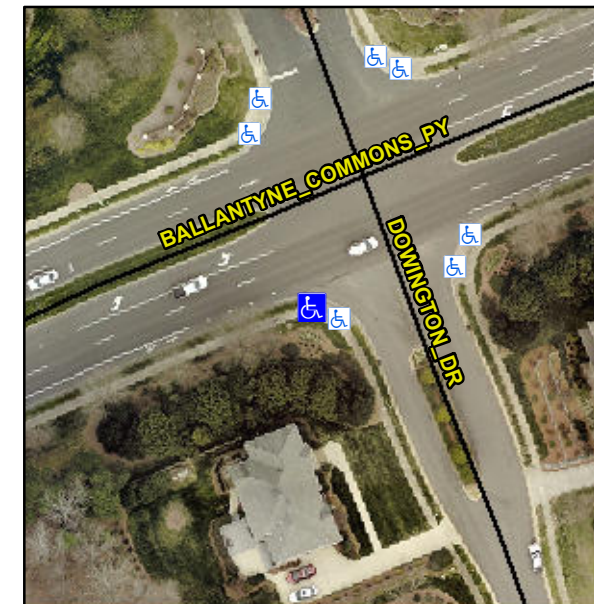
Not Found, R304.5.1, R304.5.3

Compliance	Description	Data	Compliance	Description	Data
N/A	Ramp Length (in)	107.0	Yes	Ramp Slope (%)	5.4
No	Ramp Width (in)	37.5	No	Ramp XSlope (%)	3.0
N/A	Flare Type LT	N/A	N/A	Flare Type RT	N/A
N/A	Flare Slope LT (%)	N/A	N/A	Flare Slope RT (%)	N/A
N/A	Flare Traversable LT?	N/A	N/A	Flare Traversable RT?	N/A
N/A	Landing Length (in)	N/A	N/A	DWS Provided?	N/A
N/A	Landing Width (in)	N/A	N/A	DWS Contrast?	N/A
N/A	Landing Slope (%)	N/A	N/A	DWS Length (in)	N/A
N/A	Landing X Slope (%)	N/A	N/A	DWS Full Width?	N/A
N/A	Landing Curb? (Y/N)	N/A	N/A	DWS Offset (in)	N/A
N/A	Shared Landing?	N/A			
N/A	Gutter Ponding?	N/A	N/A	Gutter Slope (%)	N/A
N/A	Gutter Lip Ht (in)	N/A	N/A	Gutter X Slope (%)	N/A
N/A	Painted X Walk1?	No	N/A	Painted X Walk2?	N/A
	X Walk 1 Direction	To N		X Walk 2 Direction	N/A
N/A	X Walk 1 Width (in)	N/A	N/A	X Walk 2 Width (in)	N/A
	X Walk 1 Slope (%)	2.7		X Walk 2 Slope (%)	N/A
	X Walk 1 X Slope (%)	2.9		X Walk 2 X Slope (%)	N/A

N/A	Ramp inside XWalk1?	N/A	N/A	Ramp inside XWalk2?	N/A
	Road Slope (%)	N/A	N/A	Clear Space?	N/A
	Road X Slope (%)	N/A	N/A	Clear Space to XWalk (in)	N/A
N/A	Any Obstructions?	N/A	N/A	Storm Grate/Utility Hazard?	N/A
	Obstruction Type			Storm Grate/Utility Type	
		N/A			N/A
			Yes	Surface Condition? (G/P)	Good

Remove & Replace Entire Ramp.
