Access Compliance Report

Public Rights-of-Way

(Curb Ramps)

Intersection ID: N/A	Main Street: STATESVILLE_AV	Cross Street: OLIVER_ST	Location: SE
ADA ID: D4595FD51768	Ramp Type: Directional1	Initial Pass/Fail: Fail	Overall Compliance: No
Codes/Mitigation Info/Possible Solution		Field Measurements/Component Compliance

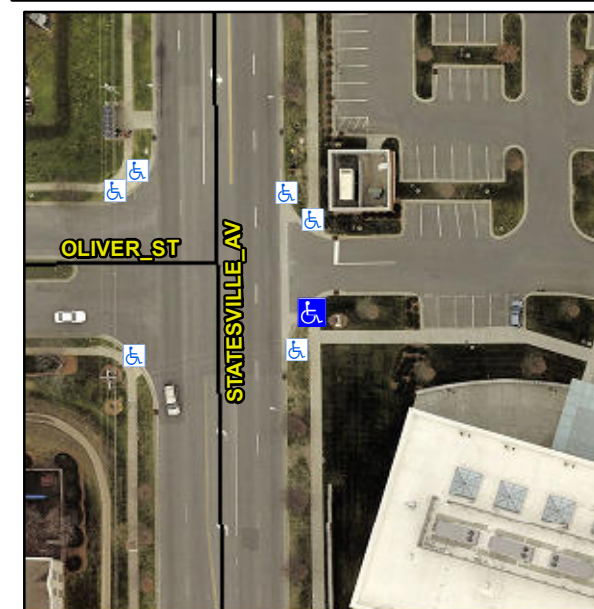
Compliance	Description	Data	Compliance	Description	Data
N/A	Ramp Length (in)	79.0	N/A	Grade Break?	N/A
Yes	Ramp Width (in)	71.0	N/A	Grade Break Slope (%)	0.0
Yes	Ramp Slope (%)	1.9	N/A	Grade Break XSlope (%)	0.0
No	Ramp XSlope (%)	5.9			
N/A	Flare Type LT	N/A	N/A	Flare Type RT	N/A
N/A	Flare Slope LT (%)	N/A	N/A	Flare Slope RT (%)	0.0
N/A	Flare Traversable LT?	N/A	N/A	Flare Traversable RT?	N/A
N/A	Landing Length (in)	0.0	N/A	DWS Provided?	N/A
N/A	Landing Width (in)	0.0	N/A	DWS Contrast?	N/A
N/A	Landing Slope (%)	0.0	N/A	DWS Length (in)	N/A
N/A	Landing X Slope (%)	0.0	N/A	DWS Full Width?	N/A
N/A	Landing Curb? (Y/N)	N/A	N/A	DWS Offset LT (in)	N/A
N/A	Shared Landing?	N/A	N/A	DWS Offset RT (in)	N/A
N/A	Gutter Ponding?	0.0	N/A	Gutter Slope (%)	N/A
N/A	Gutter Lip Ht (in)	0.0	N/A	Gutter X Slope (%)	N/A
N/A	Painted X Walk1?	No		Road Slope (%)	0.5
	X Walk 1 Direction	To NW		Road X Slope (%)	7.6
	X Walk 1 Width (in)	N/A		Clear Space?	N/A

X Walk 1 Slope (%)	0.5	N/A	Clear Space to XWalk (in)	N/A
	X Walk 1 X Slope (%)	7.6	N/A	Storm Grate/Utility Hazard?	N/A
N/A	Ramp inside XWalk1?	N/A		Storm Grate/Utility Type	
N/A	Any Obstructions?	N/A			N/A
	Obstruction Type		Yes	Surface Condition? (G/P)	Good
			N/A	Curb Slope (%)	10.9

Possible Solutions:

Remove & Replace Entire Ramp.

PROW/ADA:

R304.5.3
