Access Compliance Report Public Rights-of-Way (Curb Ramps)

Intersection ID: 18700 Main Street: PELHAM_LN Cross Street: SHARON_LN Location: E

ADA ID: D462C1CD6293 Ramp Type: PerpDiag Initial Pass/Fail: Fail Overall Compliance: No Severity Score: 12.5

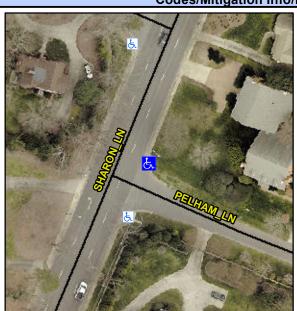
PROW/ADA:
Not Found, R304.2.2

Field Measurements/Component Compliance					
Compliance Description		Data	Compliance Description		Data
N/A	A Ramp Length (in)	75.0	No	Ramp Slope (%)	9.1
Ye	s Ramp Width (in)	49.0	Yes	Ramp XSlope (%)	1.8
N/A	A Flare Type LT	N/A	N/A	Flare Type RT	N/A
N/A	A Flare Slope LT (%)	N/A	N/A	Flare Slope RT (%)	N/A
N/A	A Flare Traversable LT?	N/A	N/A	Flare Traversable RT?	N/A
N/A	A Landing Length (in)	N/A	N/A	DWS Provided?	N/A
N/A	A Landing Width (in)	N/A	N/A	DWS Contrast?	N/A
N/A	A Landing Slope (%)	N/A	N/A	DWS Length (in)	N/A
N/A	A Landing X Slope (%)	N/A	N/A	DWS Full Width?	N/A
N/A	A Landing Curb? (Y/N)	N/A	N/A	DWS Offset (in)	N/A
N/A	A Shared Landing?	N/A			
N/A	A Gutter Ponding?	N/A	N/A	Gutter Slope (%)	N/A
N/A	Gutter Lip Ht (in)	N/A	N/A	Gutter X Slope (%)	N/A
N/A	A Painted X Walk1?	No	N/A	Painted X Walk2?	No
	X Walk 1 Direction	To NW		X Walk 2 Direction	To SW
N/A	X Walk 1 Width (in)	N/A	N/A	X Walk 2 Width (in)	N/A

X Walk 1 Slope (%)	3.8		X Walk 2 Slope (%)	0.7
	X Walk 1 X Slope (%)	0.8		X Walk 2 X Slope (%)	4.5
N/A	A Ramp inside XWalk1?	N/A	N/A	Ramp inside XWalk2?	N/A
	Road Slope (%)	0.7	N/A	Clear Space?	N/A
	Road X Slope (%)	5.2	N/A	Clear Space to XWalk (in)	N/A
N/A	Any Obstructions?	N/A	N/A	Storm Grate/Utility Hazard?	N/A
	Obstruction Type			Storm Grate/Utility Type	
		N/A			N/A
			Yes	Surface Condition? (G/P)	Good

SHARON LN None PELHAM LN StopSign Possible Solutions:

Remove & Replace Curb Ramp With
Two New Directional Ramps or
Equivalent.
