Access Compliance Report

Public Rights-of-Way

(Curb Ramps)

Intersection ID: 10036062	Main Street: RIVERGATE_PY	Cross Street: N/A	Location: SW
ADA ID: D471A9E3AD81	Ramp Type: PerpDiag	Initial Pass/Fail: Fail	Overall Compliance: No
		Severity Score: 22.5

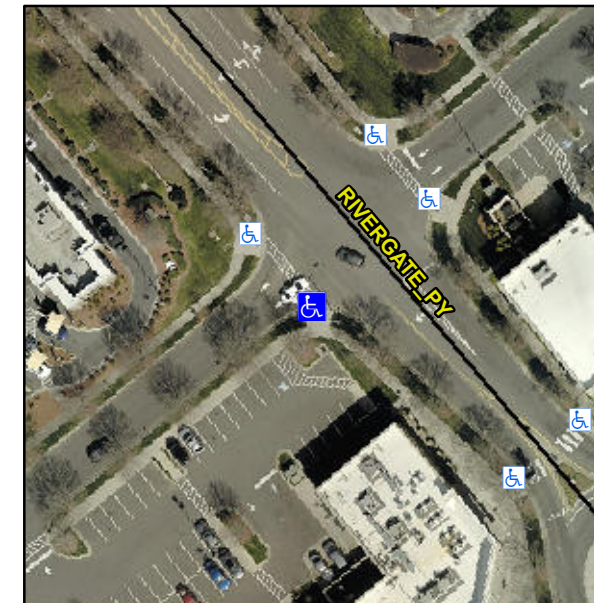
Not Found, R304.5.1, R304.2.2, R304.5.3

Compliance	Description	Data	Compliance	Description	Data
N/A	Ramp Length (in)	96.0	No	Ramp Slope (%)	8.6
No	Ramp Width (in)	41.0	No	Ramp XSlope (%)	3.2
N/A	Flare Type LT	N/A	N/A	Flare Type RT	N/A
N/A	Flare Slope LT (%)	N/A	N/A	Flare Slope RT (%)	N/A
N/A	Flare Traversable LT?	N/A	N/A	Flare Traversable RT?	N/A
N/A	Landing Length (in)	N/A	N/A	DWS Provided?	N/A
N/A	Landing Width (in)	N/A	N/A	DWS Contrast?	N/A
N/A	Landing Slope (%)	N/A	N/A	DWS Length (in)	N/A
N/A	Landing X Slope (%)	N/A	N/A	DWS Full Width?	N/A
N/A	Landing Curb? (Y/N)	N/A	N/A	DWS Offset (in)	N/A
N/A	Shared Landing?	N/A			
N/A	Gutter Ponding?	N/A	N/A	Gutter Slope (%)	N/A
N/A	Gutter Lip Ht (in)	N/A	N/A	Gutter X Slope (%)	N/A
N/A	Painted X Walk1?	No	N/A	Painted X Walk2?	Yes
	X Walk 1 Direction	To E		X Walk 2 Direction	To N
N/A	X Walk 1 Width (in)	N/A	N/A	X Walk 2 Width (in)	52.0
	X Walk 1 Slope (%)	0.1		X Walk 2 Slope (%)	0.6
	X Walk 1 X Slope (%)	0.6		X Walk 2 X Slope (%)	2.3

N/A	Ramp inside XWalk1?	N/A	N/A	Ramp inside XWalk2?	Yes
	Road Slope (%)	2.3	N/A	Clear Space?	N/A
	Road X Slope (%)	2.7	N/A	Clear Space to XWalk (in)	N/A
N/A	Any Obstructions?	N/A	N/A	Storm Grate/Utility Hazard?	N/A
	Obstruction Type			Storm Grate/Utility Type	
		N/A			N/A
			Yes	Surface Condition? (G/P)	Good

Remove & Replace Curb Ramp With Two New Directional Ramps or Equivalent.
