## Access Compliance Report Public Rights-of-Way (Curb Ramps)

Intersection ID: 23300 Main Street: SHARON\_RD\_WEST Cross Street: SHARONBROOK\_DR Location: S

ADA ID: D486D30FDF91 Ramp Type: Perp Initial Pass/Fail: Fail Overall Compliance: No Severity Score: 33.75

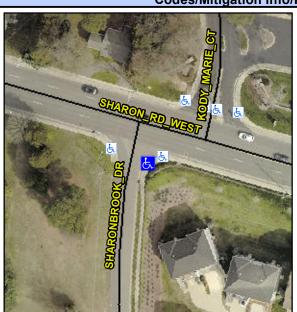
Not Found, R304.5.1, R304.2.2, R304.5.3

Field Measurements/Component Compliance								
Comp	liance Description	Data	Comp	liance	Description	Data		
N/A	Ramp Length (in)	61.0	No	Ramp	Slope (%)	9.6		
No	Ramp Width (in)	38.0	No	Ramp	XSlope (%)	6.1		
N/A	Flare Type LT	N/A	N/A	Flare	Type RT	N/A		
N/A	Flare Slope LT (%)	N/A	N/A	/A Flare Slope RT (%)				
N/A	Flare Traversable LT?	N/A	N/A	Flare	Traversable RT?	N/A		
N/A	Landing Length (in)	N/A	N/A	DWS	Provided?	N/A		
N/A	Landing Width (in)	N/A	N/A	DWS	Contrast?	N/A		
N/A	Landing Slope (%)	N/A	N/A	DWS	Length (in)	N/A		
N/A	Landing X Slope (%)	N/A	N/A	DWS	Full Width?	N/A		
N/A	Landing Curb? (Y/N)	N/A	N/A	DWS	Offset (in)	N/A		
N/A	Shared Landing?	N/A						
N/A	Gutter Ponding?	N/A	N/A	Gutte	r Slope (%)	N/A		
N/A	Gutter Lip Ht (in)	N/A	N/A	Gutte	r X Slope (%)	N/A		
N/A	Painted X Walk1?	No	N/A	Paint	ed X Walk2?	N/A		
	X Walk 1 Direction	To NW		X Wa	lk 2 Direction	N/A		
N/A	X Walk 1 Width (in)	N/A	N/A	X Wa	lk 2 Width (in)	N/A

X Walk 1 Slope (%)	2.3		X Wa	lk 2 Slope (%)	N/A		
	X Walk 1 X Slope (%)	2.6		X Wa	lk 2 X Slope (%)	N/A		
N/A	Ramp inside XWalk1?	N/A	N/A	Ram	inside XWalk2?	N/A		
	Road Slope (%)	N/A	N/A	Clear	Space?	N/A		
	Road X Slope (%)	N/A	N/A	Clear	Space to XWalk (in)	N/A		
N/A	Any Obstructions?	N/A	N/A	Storn	n Grate/Utility Hazard?	N/A		
	Obstruction Type			Storn	n Grate/Utility Type			
		N/A				N/A		
			Yes	Surfa	ce Condition? (G/P)	Good

Remove & Replace Entire Ramp.

Total Cost:	\$ 1850.00
