Access Compliance Report

Public Rights-of-Way

(Curb Ramps)

Intersection ID: 10570	Main Street: HERRIN_AV	Cross Street: HOLT_ST	Location: SE
ADA ID: D4876ED0CF14	Ramp Type: Perp	Initial Pass/Fail: Fail	Overall Compliance: No
Severity Score: 8.75			
Codes/Mitigation Info/Possible Solution		Field Measurements/Component Compliance

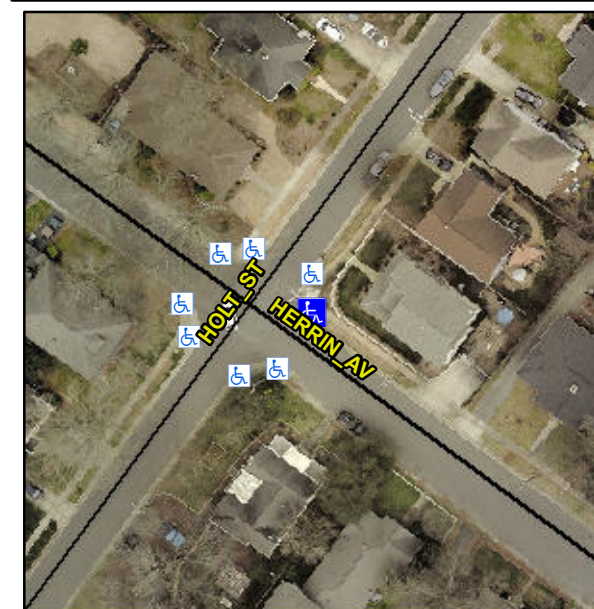
Not Found, R304.5.1

Compliance	Description	Data	Compliance	Description	Data
N/A	Ramp Length (in)	39.5	Yes	Ramp Slope (%)	6.4
No	Ramp Width (in)	47.0	Yes	Ramp XSlope (%)	1.2
N/A	Flare Type LT	N/A	N/A	Flare Type RT	N/A
N/A	Flare Slope LT (%)	N/A	N/A	Flare Slope RT (%)	N/A
N/A	Flare Traversable LT?	N/A	N/A	Flare Traversable RT?	N/A
N/A	Landing Length (in)	N/A	N/A	DWS Provided?	N/A
N/A	Landing Width (in)	N/A	N/A	DWS Contrast?	N/A
N/A	Landing Slope (%)	N/A	N/A	DWS Length (in)	N/A
N/A	Landing X Slope (%)	N/A	N/A	DWS Full Width?	N/A
N/A	Landing Curb? (Y/N)	N/A	N/A	DWS Offset (in)	N/A
N/A	Shared Landing?	N/A			
N/A	Gutter Ponding?	N/A	N/A	Gutter Slope (%)	N/A
N/A	Gutter Lip Ht (in)	N/A	N/A	Gutter X Slope (%)	N/A
N/A	Painted X Walk1?	No	N/A	Painted X Walk2?	N/A
	X Walk 1 Direction	To SW		X Walk 2 Direction	N/A
N/A	X Walk 1 Width (in)	N/A	N/A	X Walk 2 Width (in)	N/A
	X Walk 1 Slope (%)	0.1		X Walk 2 Slope (%)	N/A
	X Walk 1 X Slope (%)	1.9		X Walk 2 X Slope (%)	N/A

N/A	Ramp inside XWalk1?	N/A	N/A	Ramp inside XWalk2?	N/A
	Road Slope (%)	N/A	N/A	Clear Space?	N/A
	Road X Slope (%)	N/A	N/A	Clear Space to XWalk (in)	N/A
N/A	Any Obstructions?	N/A	N/A	Storm Grate/Utility Hazard?	N/A
	Obstruction Type			Storm Grate/Utility Type	
		N/A			N/A
			Yes	Surface Condition? (G/P)	Good

Possible Solutions:

Remove & Replace Entire Ramp.

Total Cost: \$ 1850.00
