Access Compliance Report

Public Rights-of-Way

(Curb Ramps)

Intersection ID: 28962	Main Street: HORNELL_PL	Cross Street: TROTWOOD_DR	Location: SW
ADA ID: D4AFEB18B78F	Ramp Type: Perp	Initial Pass/Fail: Fail	Overall Compliance: No
Severity Score: 10			
Codes/Mitigation Info/Possible Solution		Field Measurements/Component Compliance

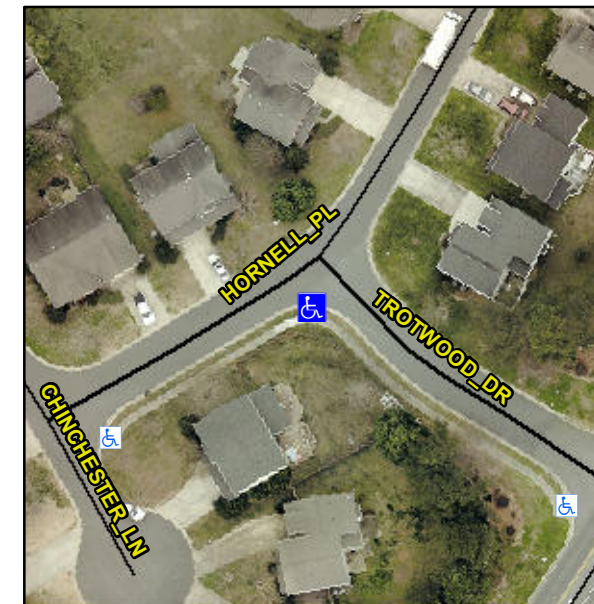
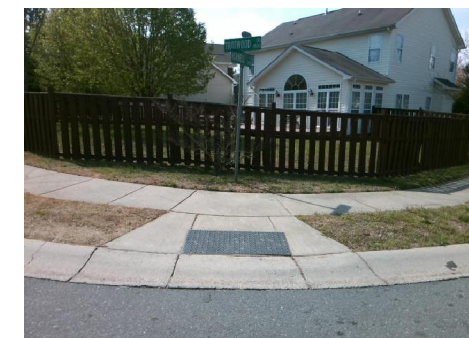
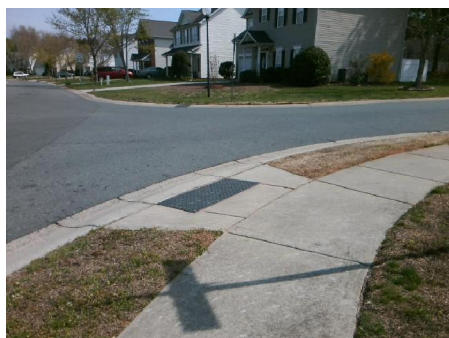
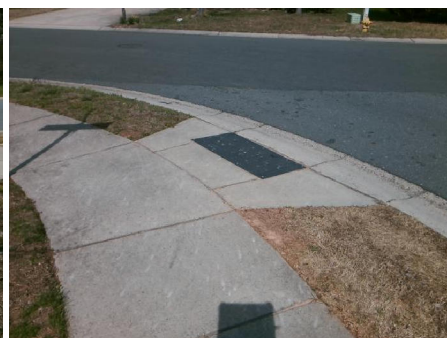
Not Found, R304.5.1, R304.5.3

Compliance	Description	Data	Compliance	Description	Data
N/A	Ramp Length (in)	45.5	Yes	Ramp Slope (%)	8.2
No	Ramp Width (in)	39.5	No	Ramp XSlope (%)	2.6
N/A	Flare Type LT	N/A	N/A	Flare Type RT	N/A
N/A	Flare Slope LT (%)	N/A	N/A	Flare Slope RT (%)	N/A
N/A	Flare Traversable LT?	N/A	N/A	Flare Traversable RT?	N/A
N/A	Landing Length (in)	N/A	N/A	DWS Provided?	N/A
N/A	Landing Width (in)	N/A	N/A	DWS Contrast?	N/A
N/A	Landing Slope (%)	N/A	N/A	DWS Length (in)	N/A
N/A	Landing X Slope (%)	N/A	N/A	DWS Full Width?	N/A
N/A	Landing Curb? (Y/N)	N/A	N/A	DWS Offset (in)	N/A
N/A	Shared Landing?	N/A			
N/A	Gutter Ponding?	N/A	N/A	Gutter Slope (%)	N/A
N/A	Gutter Lip Ht (in)	N/A	N/A	Gutter X Slope (%)	N/A
N/A	Painted X Walk1?	No	N/A	Painted X Walk2?	N/A
	X Walk 1 Direction	To E		X Walk 2 Direction	N/A
N/A	X Walk 1 Width (in)	N/A	N/A	X Walk 2 Width (in)	N/A
	X Walk 1 Slope (%)	3.5		X Walk 2 Slope (%)	N/A
	X Walk 1 X Slope (%)	0.6		X Walk 2 X Slope (%)	N/A

N/A	Ramp inside XWalk1?	N/A	N/A	Ramp inside XWalk2?	N/A
	Road Slope (%)	0.6	N/A	Clear Space?	N/A
	Road X Slope (%)	3.5	N/A	Clear Space to XWalk (in)	N/A
N/A	Any Obstructions?	N/A	N/A	Storm Grate/Utility Hazard?	N/A
	Obstruction Type			Storm Grate/Utility Type	
		N/A			N/A
			Yes	Surface Condition? (G/P)	Good

Possible Solutions:

Remove & Replace Entire Ramp.
