| Intersection ID: 45539 | Main Street: PEACHTREE_RD | Cross Street: CORVUS_CT | Location: | SE |
| ADA ID: D4B51575493B | Ramp Type: PerpDiag | Initial Pass/Fail: Fail | Overall Compliance: No | Severity Score: 8.75 |

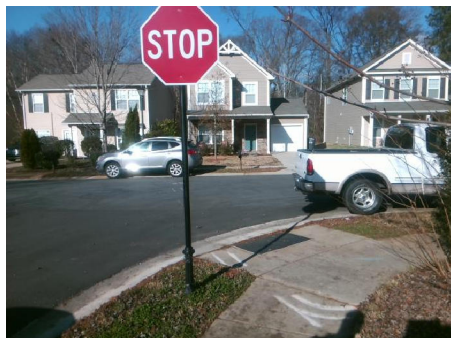
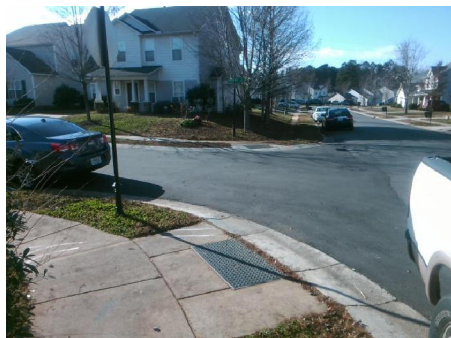
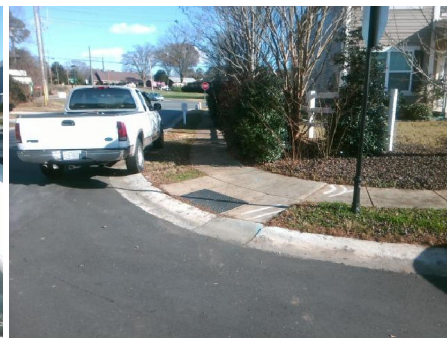
**Not Found, R304.5.1**

| Compliance | Description | Data | Compliance | Description | Data |
|---|---|---|---|---|---|
| No | Ramp Width (in) | 39.0 | Yes | Ramp XSlope (%) | 1.0 |

**Remove & Replace Curb Ramp With Two New Directional Ramps or Equivalent.**
