Access Compliance Report

Public Rights-of-Way

(Curb Ramps)

Intersection ID: 32275	Main Street: PRESCOTT_HILL_AV	Cross Street: SPRINGWELL_ST	Location: W
ADA ID: D4BADE1B467A	Ramp Type: Perp	Initial Pass/Fail: Fail	Overall Compliance: No
Severity Score: 12.5			
Codes/Mitigation Info/Possible Solution		Field Measurements/Component Compliance

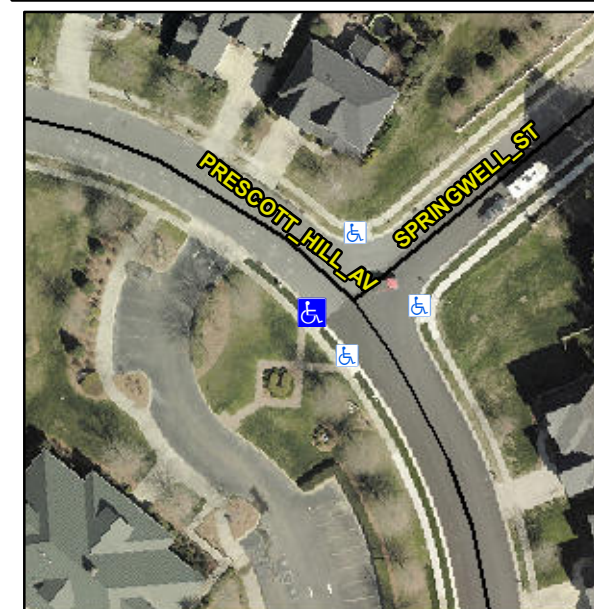
Not Found, R304.2.2

Compliance	Description	Data	Compliance	Description	Data
N/A	Ramp Length (in)	49.0	No	Ramp Slope (%)	10.0
Yes	Ramp Width (in)	61.0	Yes	Ramp XSlope (%)	1.0
N/A	Flare Type LT	N/A	N/A	Flare Type RT	N/A
N/A	Flare Slope LT (%)	N/A	N/A	Flare Slope RT (%)	N/A
N/A	Flare Traversable LT?	N/A	N/A	Flare Traversable RT?	N/A
N/A	Landing Length (in)	N/A	N/A	DWS Provided?	N/A
N/A	Landing Width (in)	N/A	N/A	DWS Contrast?	N/A
N/A	Landing Slope (%)	N/A	N/A	DWS Length (in)	N/A
N/A	Landing X Slope (%)	N/A	N/A	DWS Full Width?	N/A
N/A	Landing Curb? (Y/N)	N/A	N/A	DWS Offset (in)	N/A
N/A	Shared Landing?	N/A			
N/A	Gutter Ponding?	N/A	N/A	Gutter Slope (%)	N/A
N/A	Gutter Lip Ht (in)	N/A	N/A	Gutter X Slope (%)	N/A
N/A	Painted X Walk1?	No	N/A	Painted X Walk2?	N/A
	X Walk 1 Direction	To N		X Walk 2 Direction	N/A
N/A	X Walk 1 Width (in)	N/A	N/A	X Walk 2 Width (in)	N/A
	X Walk 1 Slope (%)	5.2		X Walk 2 Slope (%)	N/A
	X Walk 1 X Slope (%)	0.6		X Walk 2 X Slope (%)	N/A

N/A	Ramp inside XWalk1?	N/A	N/A	Ramp inside XWalk2?	N/A
	Road Slope (%)	N/A	N/A	Clear Space?	N/A
	Road X Slope (%)	N/A	N/A	Clear Space to XWalk (in)	N/A
N/A	Any Obstructions?	N/A	N/A	Storm Grate/Utility Hazard?	N/A
	Obstruction Type			Storm Grate/Utility Type	
		N/A			N/A
			Yes	Surface Condition? (G/P)	Good

Possible Solutions:

Remove & Replace Entire Ramp.

Total Cost: \$ 1850.00
