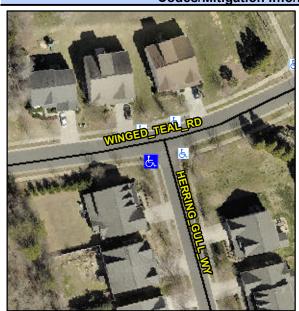
Intersection ID: 47456Main Street:WINGED_TEAL_RDCross Street: HERRING_GULL_WYLocation:SWADA ID: D4C0B5A8A7E6Ramp Type:PerpDiagInitial Pass/Fail: FailOverall Compliance: NoSeverity Score:22.5

Field Measurements/Component Compliance						
	Compliance Description		Data	Comp	liance Description	Data
	N/A	Ramp Length (in)	46.0	No	Ramp Slope (%)	8.4
	No	Ramp Width (in)	47.8	No	Ramp XSlope (%)	3.3
	N/A	Flare Type LT	N/A	N/A	Flare Type RT	N/A
	N/A	Flare Slope LT (%)	N/A	N/A	Flare Slope RT (%)	N/A
	N/A	Flare Traversable LT?	N/A	N/A	Flare Traversable RT?	N/A
	N/A	Landing Length (in)	N/A	N/A	DWS Provided?	N/A
	N/A	Landing Width (in)	N/A	N/A	DWS Contrast?	N/A
	N/A	Landing Slope (%)	N/A	N/A	DWS Length (in)	N/A
	N/A	Landing X Slope (%)	N/A	N/A	DWS Full Width?	N/A
	N/A	Landing Curb? (Y/N)	N/A	N/A	DWS Offset (in)	N/A
	N/A	Shared Landing?	N/A			
	N/A	Gutter Ponding?	N/A	N/A	Gutter Slope (%)	N/A
	N/A	Gutter Lip Ht (in)	N/A	N/A	Gutter X Slope (%)	N/A
	N/A	Painted X Walk1?	No	N/A	Painted X Walk2?	No
		X Walk 1 Direction	To E		X Walk 2 Direction	To N
	N/A	X Walk 1 Width (in)	N/A	N/A	X Walk 2 Width (in)	N/A
		X Walk 1 Slope (%)	3.0		X Walk 2 Slope (%)	3.3

X Walk 1 X Slope (%)	2.9		X Walk 2 X Slope (%)	3.3
	N/A	Ramp inside XWalk1?	N/A	N/A	Ramp inside XWalk2?	N/A
		Road Slope (%)	4.4	N/A	Clear Space?	N/A
		Road X Slope (%)	2.0	N/A	Clear Space to XWalk (in)	N/A
	N/A	Any Obstructions?	N/A	N/A	Storm Grate/Utility Hazard?	N/A
		Obstruction Type			Storm Grate/Utility Type	
			N/A			N/A
				Yes	Surface Condition? (G/P)	Good
_		THE RESERVE OF THE PERSON OF T

Remove & Replace Curb Ramp With Two New Directional Ramps or Equivalent.
