# Access Compliance Report

## Public Rights-of-Way

### (Curb Ramps)

Intersection ID: 20578	Main Street: EMERALD_MEADOW_LN	Cross Street: ENGLISH_SADDLE_LN	Location: W
ADA ID: D4E04061FC92	Ramp Type: PerpDiag	Initial Pass/Fail: Fail	Overall Compliance: No
Severity Score: 22.5			
Codes/Mitigation Info/Possible Solution		Field Measurements/Component Compliance

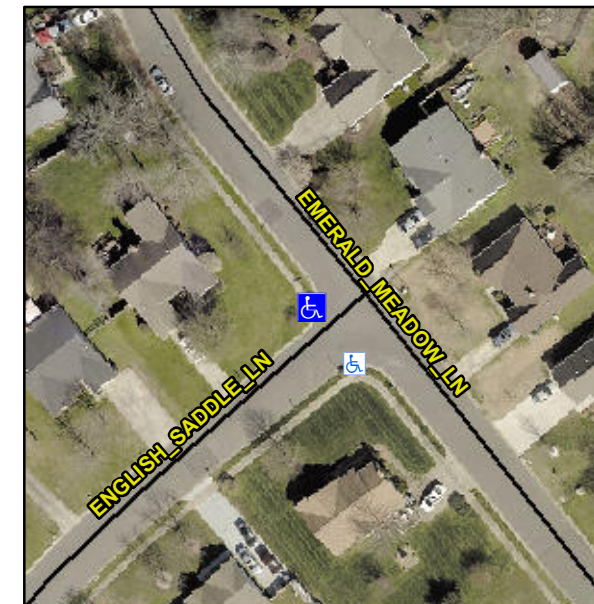
Compliance	Description	Data	Compliance	Description	Data
N/A	Ramp Length (in)	48.0	No	Ramp Slope (%)	8.5
No	Ramp Width (in)	39.0	No	Ramp XSlope (%)	2.8
N/A	Flare Type LT	N/A	N/A	Flare Type RT	N/A
N/A	Flare Slope LT (%)	N/A	N/A	Flare Slope RT (%)	N/A
N/A	Flare Traversable LT?	N/A	N/A	Flare Traversable RT?	N/A
N/A	Landing Length (in)	N/A	N/A	DWS Provided?	N/A
N/A	Landing Width (in)	N/A	N/A	DWS Contrast?	N/A
N/A	Landing Slope (%)	N/A	N/A	DWS Length (in)	N/A
N/A	Landing X Slope (%)	N/A	N/A	DWS Full Width?	N/A
N/A	Landing Curb? (Y/N)	N/A	N/A	DWS Offset (in)	N/A
N/A	Shared Landing?	N/A			
N/A	Gutter Ponding?	N/A	N/A	Gutter Slope (%)	N/A
N/A	Gutter Lip Ht (in)	N/A	N/A	Gutter X Slope (%)	N/A
N/A	Painted X Walk1?	No	N/A	Painted X Walk2?	No
	X Walk 1 Direction	To SE		X Walk 2 Direction	To NE
N/A	X Walk 1 Width (in)	N/A	N/A	X Walk 2 Width (in)	N/A
	X Walk 1 Slope (%)	1.9		X Walk 2 Slope (%)	2.4
	X Walk 1 X Slope (%)	2.2		X Walk 2 X Slope (%)	1.3

N/A	Ramp inside XWalk1?	N/A	N/A	Ramp inside XWalk2?	N/A
	Road Slope (%)	0.9	N/A	Clear Space?	N/A
	Road X Slope (%)	3.4	N/A	Clear Space to XWalk (in)	N/A
N/A	Any Obstructions?	N/A	N/A	Storm Grate/Utility Hazard?	N/A
	Obstruction Type			Storm Grate/Utility Type	
		N/A			N/A
			Yes	Surface Condition? (G/P)	Good

**Remove & Replace Curb Ramp With Two New Directional Ramps or Equivalent.**

Total Cost: \$ 3200.00
