# Access Compliance Report

## Public Rights-of-Way

### (Curb Ramps)

Intersection ID: 13296	Main Street: CENTRAL_AV	Cross Street: MORNINGSIDE_DR	Location: SW
ADA ID: D4E7515EBA04	Ramp Type: PerpDiag	Initial Pass/Fail: Fail	Overall Compliance: No
		Severity Score: 42.5

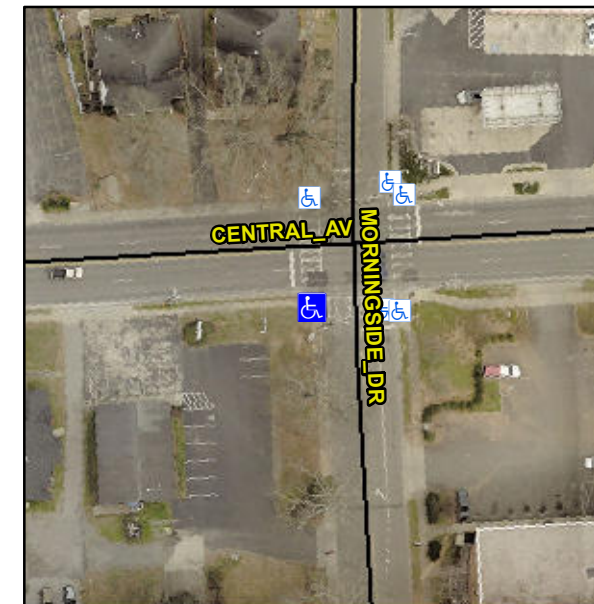
**Not Found, R304.5.1, R304.5.3**

Compliance	Description	Data	Compliance	Description	Data
N/A	Ramp Length (in)	68.0	Yes	Ramp Slope (%)	5.6
No	Ramp Width (in)	32.0	No	Ramp XSlope (%)	10.9
N/A	Flare Type LT	N/A	N/A	Flare Type RT	N/A
N/A	Flare Slope LT (%)	N/A	N/A	Flare Slope RT (%)	N/A
N/A	Flare Traversable LT?	N/A	N/A	Flare Traversable RT?	N/A
N/A	Landing Length (in)	N/A	N/A	DWS Provided?	N/A
N/A	Landing Width (in)	N/A	N/A	DWS Contrast?	N/A
N/A	Landing Slope (%)	N/A	N/A	DWS Length (in)	N/A
N/A	Landing X Slope (%)	N/A	N/A	DWS Full Width?	N/A
N/A	Landing Curb? (Y/N)	N/A	N/A	DWS Offset (in)	N/A
N/A	Shared Landing?	N/A			
N/A	Gutter Ponding?	N/A	N/A	Gutter Slope (%)	N/A
N/A	Gutter Lip Ht (in)	N/A	N/A	Gutter X Slope (%)	N/A
N/A	Painted X Walk1?	Yes	N/A	Painted X Walk2?	Yes
	X Walk 1 Direction	To E		X Walk 2 Direction	To N
N/A	X Walk 1 Width (in)	111.0	N/A	X Walk 2 Width (in)	110.0
	X Walk 1 Slope (%)	2.6		X Walk 2 Slope (%)	8.7
	X Walk 1 X Slope (%)	5.5		X Walk 2 X Slope (%)	1.3

N/A	Ramp inside XWalk1?	Yes	N/A	Ramp inside XWalk2?	Yes
	Road Slope (%)	3.7	N/A	Clear Space?	N/A
	Road X Slope (%)	3.0	N/A	Clear Space to XWalk (in)	N/A
N/A	Any Obstructions?	N/A	N/A	Storm Grate/Utility Hazard?	N/A
	Obstruction Type			Storm Grate/Utility Type	
		N/A			N/A
		Yes		Surface Condition? (G/P)	Good

**Remove & Replace Curb Ramp With Two New Directional Ramps or Equivalent.**
