Access Compliance Report

Public Rights-of-Way

(Curb Ramps)

Intersection ID: 27456	Main Street: BALLANTYNE_MEADOWS_DR	Cross Street: GRAHAMWOOD_PL	Location:	S
ADA ID: D4EDD8896AAF	Ramp Type: PerpDiag	Initial Pass/Fail: Fail	Overall Compliance: No	Severity Score: 25
Codes/Mitigation Info/Possible Solution		Field Measurements/Component Compliance

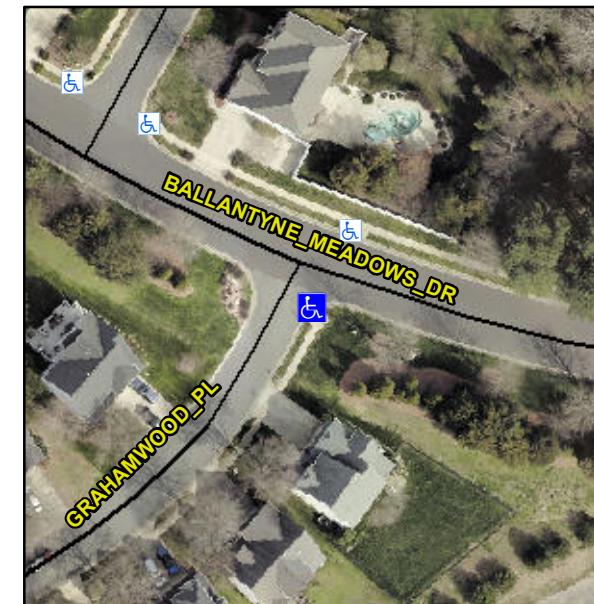
Compliance	Description	Data	Compliance	Description	Data
N/A	Ramp Length (in)	48.0	Yes	Ramp Slope (%)	7.0
Yes	Ramp Width (in)	48.0	No	Ramp XSlope (%)	8.1
N/A	Flare Type LT	N/A	N/A	Flare Type RT	N/A
N/A	Flare Slope LT (%)	N/A	N/A	Flare Slope RT (%)	N/A
N/A	Flare Traversable LT?	N/A	N/A	Flare Traversable RT?	N/A
N/A	Landing Length (in)	N/A	N/A	DWS Provided?	N/A
N/A	Landing Width (in)	N/A	N/A	DWS Contrast?	N/A
N/A	Landing Slope (%)	N/A	N/A	DWS Length (in)	N/A
N/A	Landing X Slope (%)	N/A	N/A	DWS Full Width?	N/A
N/A	Landing Curb? (Y/N)	N/A	N/A	DWS Offset (in)	N/A
N/A	Shared Landing?	N/A			
N/A	Gutter Ponding?	N/A	N/A	Gutter Slope (%)	N/A
N/A	Gutter Lip Ht (in)	N/A	N/A	Gutter X Slope (%)	N/A
N/A	Painted X Walk1?	No	N/A	Painted X Walk2?	No
	X Walk 1 Direction	To NE		X Walk 2 Direction	To NW
N/A	X Walk 1 Width (in)	N/A	N/A	X Walk 2 Width (in)	N/A
	X Walk 1 Slope (%)	5.1		X Walk 2 Slope (%)	2.4
	X Walk 1 X Slope (%)	2.1		X Walk 2 X Slope (%)	6.3

N/A	Ramp inside XWalk1?	N/A	N/A	Ramp inside XWalk2?	N/A
	Road Slope (%)	5.0	N/A	Clear Space?	N/A
	Road X Slope (%)	4.4	N/A	Clear Space to XWalk (in)	N/A
N/A	Any Obstructions?	N/A	N/A	Storm Grate/Utility Hazard?	N/A
	Obstruction Type			Storm Grate/Utility Type	
		N/A			N/A
			Yes	Surface Condition? (G/P)	Good

Remove & Replace Curb Ramp With Two New Directional Ramps or Equivalent.

R304.5.3
