Access Compliance Report Public Rights-of-Way (Curb Ramps)

_						
Intersection ID: 43145	Main Street: E_INDEPENDENCE_BV			Cross Street: E_INDEPENDENCE/BRIAR_CREEK_RA					RA Location:	SW
ADA ID: D4FFAD7CC952	Ramp Type: IslandPerp			Initial Pass/Fail: Fail Overall Complian			nce: No	o Severity Score:	33.75	
Codes/Mitigation Info/Possible Solution				Field Measurements/Component Compliance						
	11	Possible Solutions:	Compliance Description			Data	Data Compliance Description			
and the second second		Remove & Repla	ce Entire Ramp.		N/A	Ramp Length (in)	24.0	No	Ramp Slope (%)	16.3
COLE: A COLE	A. C.		•		No	Ramp Width (in)	39.0	Yes	Ramp XSlope (%)	0.7
	Q3 A				N/A	Flare Type LT	N/A	N/A	Flare Type RT	N/A

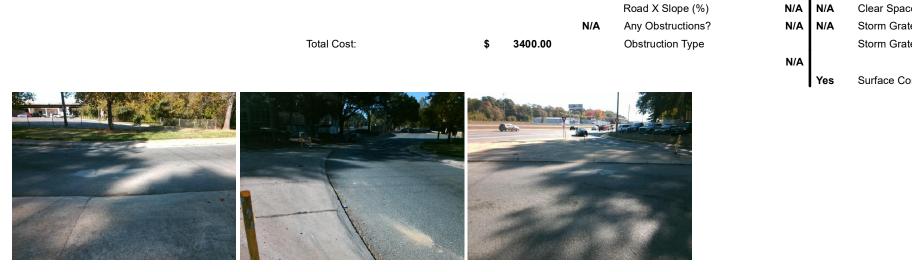
- Colo				N/A	Flare Slope LT (%)	N/A	N/A	Flare Slope RT (%)	N/A
S	Ser .				N/A	Flare Traversable LT?	N/A	N/A	Flare Traversable RT?	N/A
A BA	1	-			N/A	Landing Length (in)	N/A	N/A	DWS Provided?	N/A
		Surveyor Notes:			N/A	Landing Width (in)	N/A	N/A	DWS Contrast?	N/A
		N/A			N/A	Landing Slope (%)	N/A	N/A	DWS Length (in)	N/A
	and a				N/A	Landing X Slope (%)	N/A	N/A	DWS Full Width?	N/A
States and a state	Contraction of the local division of the loc				N/A	Landing Curb? (Y/N)	N/A	N/A	DWS Offset (in)	N/A
	Sindle and	*			N/A	Shared Landing?	N/A			
31 A		PROW/ADA:			N/A	Gutter Ponding?	N/A	N/A	Gutter Slope (%)	N/A
SI 23 0 0 0 0 0 0 0 0 0 0 0 0 0 0 0 0 0 0	Not Found, R304	1.5.1. R304.2.2		N/A	Gutter Lip Ht (in)	N/A	N/A	Gutter X Slope (%)	N/A	
		,	,		N/A	Painted X Walk1?	No	N/A	Painted X Walk2?	N/A
		~				X Walk 1 Direction	To W		X Walk 2 Direction	N/A

J. A.				N/A	X Walk 1 Width (in)	N/A	N/A	X Walk 2 Width (in)	N/A
Street 1 Name E INDEPENDENCE/BRIAR CREEK RA					X Walk 1 Slope (%)	1.2		X Walk 2 Slope (%)	N/A	
Stop Condition-Street 2	None					X Walk 1 X Slope (%)	1.9		X Walk 2 X Slope (%)	N/A
Street 2 Name	N/A				N/A	Ramp inside XWalk1?	N/A	N/A	Ramp inside XWalk2?	N/A
Stop Condition-Street 1	N/A					Road Slope (%)	N/A	N/A	Clear Space?	N/A
						Road X Slope (%)	N/A	N/A	Clear Space to XWalk (in)	N/A
					N/A	Any Obstructions?	N/A	N/A	Storm Grate/Utility Hazard?	N/A
		Total Cost:	\$ 3	400.00		Obstruction Type			Storm Grate/Utility Type	
							N/A			N/A

es Surface Condition? (G/P) Good
