Access Compliance Report

Public Rights-of-Way

(Curb Ramps)

| Intersection ID: 5598 | Main Street: MALLARD_CREEK_RD | Cross Street: MALLARD_PARK_DR | Location: S |

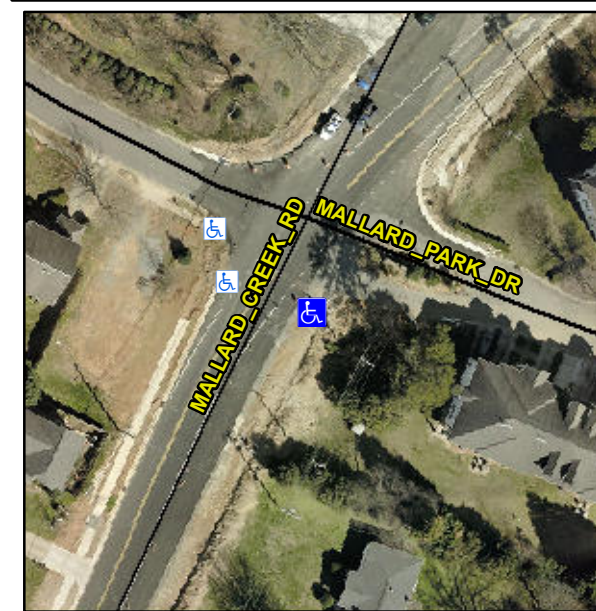
| ADA ID: D5055B51236F | Ramp Type: Perp | Initial Pass/Fail: Fail | Overall Compliance: No |
| Severity Score: 22.5 | | | |

Not Found, R304.5.1, R304.2.2, R304.5.3

| Compliance | Description | Data | Compliance | Description | Data |
|---|---|---|---|---|---|
| N/A | Ramp Length (in) | 55.0 | No | Ramp Slope (%) | 8.7 |
| No | Ramp Width (in) | 47.0 | No | Ramp XSlope (%) | 5.0 |

Remove & Replace Entire Ramp.

Total Cost: \$ 1850.00
