Access Compliance Report Public Rights-of-Way (Curb Ramps)

Intersection ID: 12876 Main Street: CHATHAM_AV Cross Street: WOLFE_ST Location: SW

ADA ID: D505DFA44DC9 Ramp Type: Perp Initial Pass/Fail: Fail Overall Compliance: No Severity Score: 21.25

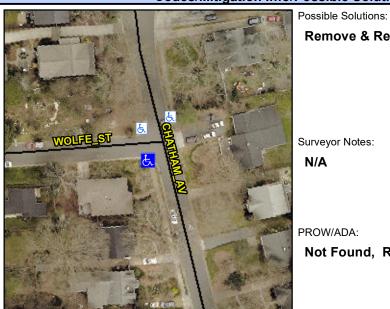
Field Measurements/Component Compliance								
Compliance Description		Data	Comp	liance Description	Data			
N/A	Ramp Length (in)	85.0	Yes	Ramp Slope (%)	5.4			
No	Ramp Width (in)	47.5	No	Ramp XSlope (%)	6.1			
N/A	Flare Type LT	N/A	N/A	Flare Type RT	N/A			
N/A	Flare Slope LT (%)	N/A	N/A	Flare Slope RT (%)	N/A			
N/A	Flare Traversable LT?	N/A	N/A	Flare Traversable RT?	N/A			
N/A	Landing Length (in)	N/A	N/A	DWS Provided?	N/A			
N/A	Landing Width (in)	N/A	N/A	DWS Contrast?	N/A			
N/A	Landing Slope (%)	N/A	N/A	DWS Length (in)	N/A			
N/A	Landing X Slope (%)	N/A	N/A	DWS Full Width?	N/A			
N/A	Landing Curb? (Y/N)	N/A	N/A	DWS Offset (in)	N/A			
N/A	Shared Landing?	N/A						
N/A	Gutter Ponding?	N/A	N/A	Gutter Slope (%)	N/A			
N/A	Gutter Lip Ht (in)	N/A	N/A	Gutter X Slope (%)	N/A			
N/A	Painted X Walk1?	No	N/A	Painted X Walk2?	N/A			
	X Walk 1 Direction	To N		X Walk 2 Direction	N/A			
N/A	X Walk 1 Width (in)	N/A	N/A	X Walk 2 Width (in)	N/A

X Walk 1 Slope (%)	4.9		X Walk 2 Slope (%)	N/A			
	X Walk 1 X Slope (%)	0.4		X Walk 2 X Slope (%)	N/A			
N/A	Ramp inside XWalk1?	N/A	N/A	Ramp inside XWalk2?	N/A			
	Road Slope (%)	N/A	N/A	Clear Space?	N/A			
	Road X Slope (%)	N/A	N/A	Clear Space to XWalk (in)	N/A			
N/A	Any Obstructions?	N/A	N/A	Storm Grate/Utility Hazard?	N/A			
	Obstruction Type			Storm Grate/Utility Type				
		N/A			N/A			
			Yes	Surface Condition? (G/P)	Good

п		_
	Remove & Replace Entire Ramp.	1
		N
00		N
ACR. 2		N
		N
9		1
	Surveyor Notes:	N
	N/A	N
		N
		N
ľ		N
	PROW/ADA:	N
	Not Found, R304.5.1, R304.5.3	N
	,	N
Con		
		N
		N

1850.00
